1. INTRODUCTION

1.3 Background

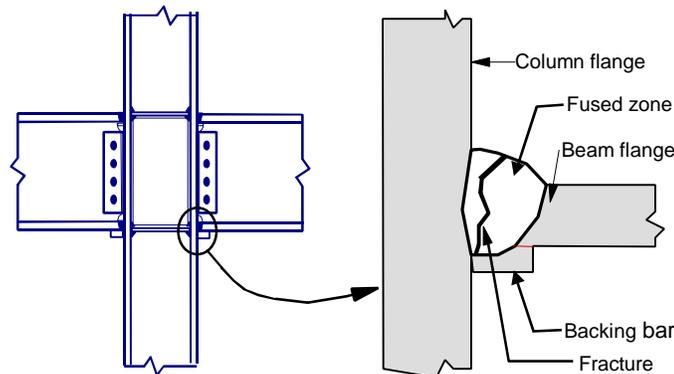
Observation of damage sustained by buildings in the Northridge Earthquake indicates that contrary to the intended behavior, in ~~some many~~ cases brittle fractures initiated within the connections at very low levels of plastic demand, and in some cases, while the structures remained essentially elastic. Typically, but not always, fractures initiated at, or near, the complete joint penetration (CJP) weld between the beam bottom flange and column flange (Figure 1-1). Once initiated, these fractures progressed along a number of different paths, depending on the individual joint and stress conditions. Figure 1-1 indicates just one of these potential fracture growth patterns. ~~Investigators initially identified a number of factors which may have contributed to the initiation of fractures at the weld root including: notch effects created by the backing bar which was commonly left in place following joint completion; sub-standard welding that included excessive porosity and slag inclusions as well as incomplete fusion;~~

and potentially, pre-earthquake fractures resulting from initial shrinkage of the highly restrained weld during cool-down. Such problems could be minimized in future construction, with the application of appropriate welding procedures and more careful exercise of quality control during the construction process. However, it is now known that these were not the only causes of the fractures which occurred.

Figure 1-1 - Common Zone of Fracture Initiation in Beam -Column Connection
