INTERIM GUIDELINES: Evaluation, Repair, Modification and Design of Steel Moment Frames

Report No. SAC-95-02

SAC Joint Venture

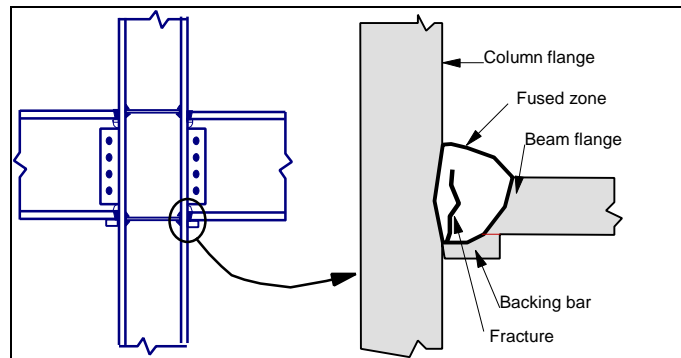
Figure 1-1 - Common Zone of Fracture Initiation in Beam -Column Connection

Observation of damage sustained by buildings in the Northridge Earthquake indicates that contrary to the intended behavior, in many cases brittle fractures initiated within the connections at very low levels of plastic demand, and in some cases, while the structures remained elastic. Typically, but not always, fractures initiated at, or near, the complete joint penetration (CJP) weld between the beam bottom flange and column flange (Figure 1-1). Once initiated, these fractures progressed along a number of different paths, depending on the individual joint conditions. Figure 1-1 indicates just one of these potential fracture growth patterns. Investigators initially identified a number of factors which may have contributed to the initiation of fractures at the weld root including: notch effects created by the backing bar which was commonly left in place following joint completion; sub-standard welding that included excessive porosity and slag inclusions as well as incomplete fusion; and potentially, pre-earthquake fractures resulting from initial shrinkage of the highly restrained weld during cool-down. Such problems could be minimized in future construction, with the application of appropriate welding procedures and more careful exercise of quality control during the construction process. However, it is now known that these were not the only causes of the fractures which occurred.

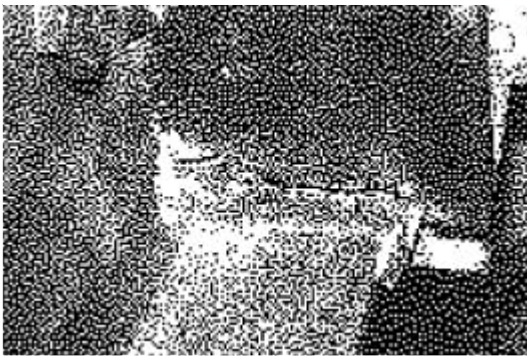
During the Northridge Earthquake, once fractures initiated in beam-column joints, they progressed in a number of different ways. In some cases, the fractures initiated but did not grow, and could not be detected by visual observation. In other cases, the fractures progressed completely through the thickness of the weld, and if fireproofing was removed, the fractures were evident as a crack through exposed faces of the weld, or the metal just behind the weld (Figure 1-2a). Other fracture patterns also developed. In some cases, the fracture developed into a through-thickness failure of the column flange material behind the CJP weld (Figure 1-2b). In these cases, a portion of the column flange remained bonded to the beam flange, but pulled free from the remainder of the column. This fracture pattern has sometimes been termed a “divot” or “nugget” failure.

a. Fracture at Fused Zone

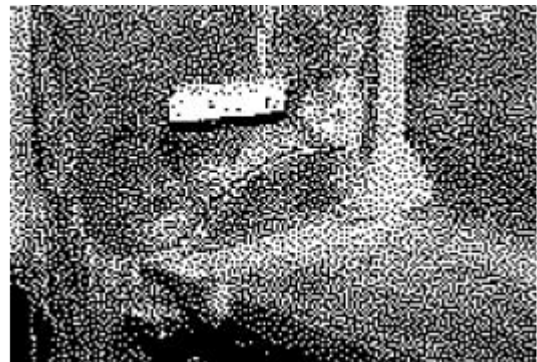
b. Column Flange “Divot” Fracture

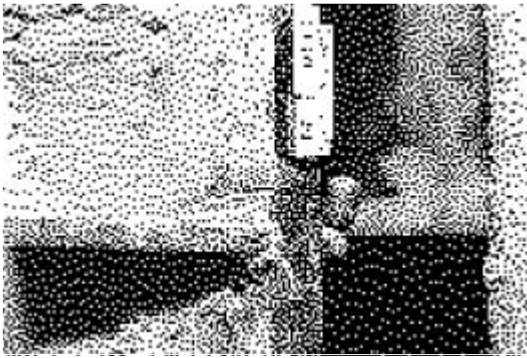
A number of fractures progressed completely through the column flange, along a near horizontal plane that aligns approximately with the beam lower flange (Figure 1-3a). In some cases, these fractures extended into the column web and progressed across the panel zone Figure (1-3b). Investigators have reported some instances where columns fractured entirely across the section.

a. Fractures through Column Flange

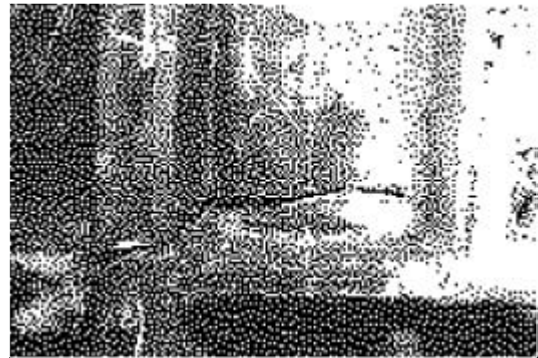
b. Fracture Progresses into Column Web

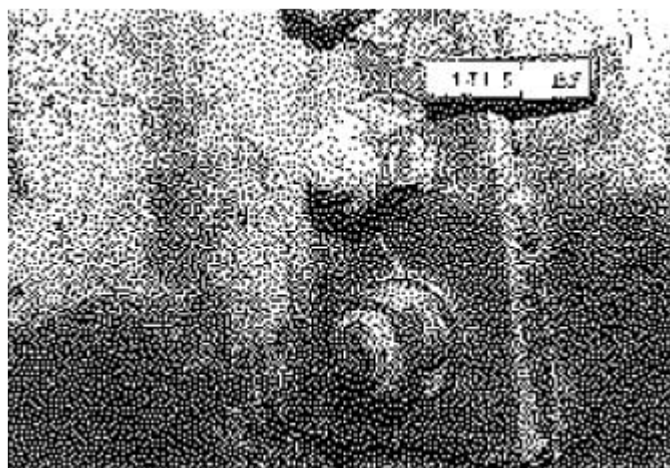
Once these fractures have occurred, the beam - column connection has experienced a significant loss of flexural rigidity and capacity. Residual flexural strength and rigidity must be developed through a couple consisting of forces transmitted through the remaining top flange connection and the web bolts. Initial research suggests that residual stiffness is approximately 20% of that of the undamaged connection and that residual strength varies from 10% to 40% of the undamaged capacity, when loading results in tensile stress normal to the fracture plane. When loading produces compression across the fracture plane, much of the original strength and stiffness remain. However, in providing this residual strength and stiffness, the beam shear connections can themselves be subject to failures, consisting of fracturing of the welds of the shear plate to the column, fracturing of supplemental welds to the beam web or fracturing through the weak section of shear plate aligning with the bolt holes (Figure 1-4).

Figure 1-4 - Vertical Fracture through Beam Shear Plate Connection
