Specimen ID: EERC-PN1  
 Keywords: Pre-Northridge, simulated field welding, panel zone yielding, weld fracture, small rotation capacity  
 Test Location: Earthquake Engineering Research Center, University of California at Berkeley  
 Test Date: March 7, 1995  
 Principal Investigator: Vitelmo V. Bertero; with Andrew S. Whittaker and Amir S. Gilani  
 Related Summaries: 13, 14  
 Reference: "Experimental Investigations of Beam-Column Subassemblages," Report No. SAC 96-01, March 1996.  
 Funding Source: FEMA / SAC Joint Venture, Phase I

**CONNECTION DETAIL**

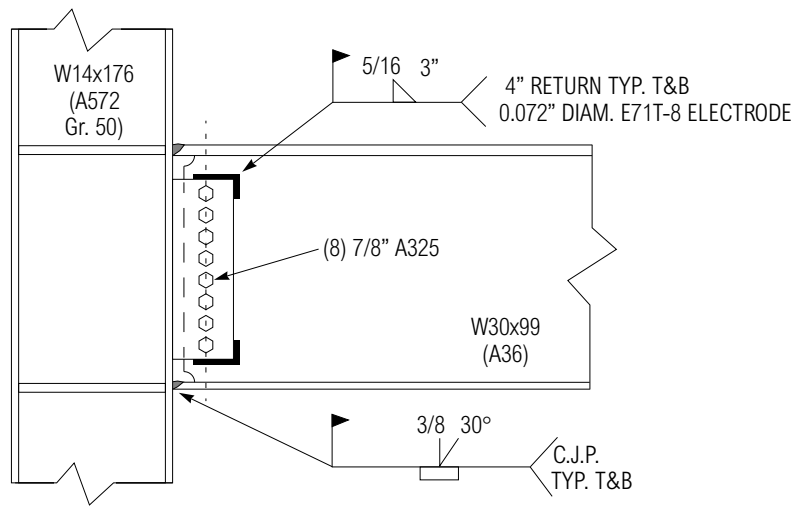
Mode of failure: Fracture of the welded beam top flange to column flange connection during the first half-cycle of loading to  $3\delta_y$ .

Specimen EERC-PN1 failed during the first half-cycle of loading to a displacement of  $3\delta_y$ . Failure occurred in the groove welded connection of the beam top flange to the column flange at a beam tip displacement of approximately 0.1 in. during the excursion. Failure of the specimen was preceded by shear yielding in the panel zone, initially observed during the first displacement cycle to  $0.75\delta_y$ . The specimen failed abruptly during the  $3\delta_y$  cycle. Data from the strain gages on the top-side of the top flange of the beam indicated flexural strains exceeding 20,000 microstrain. However, visual inspection of the specimen following the testing suggested that there was little plastification over the depth of the beam. The maximum plastic rotation of the connection prior to failure was approximately 1.1% radian: 0.7% radian in the panel zone, and 0.4% radian in the beam. The panel zone dissipated substantially more energy than the beam.

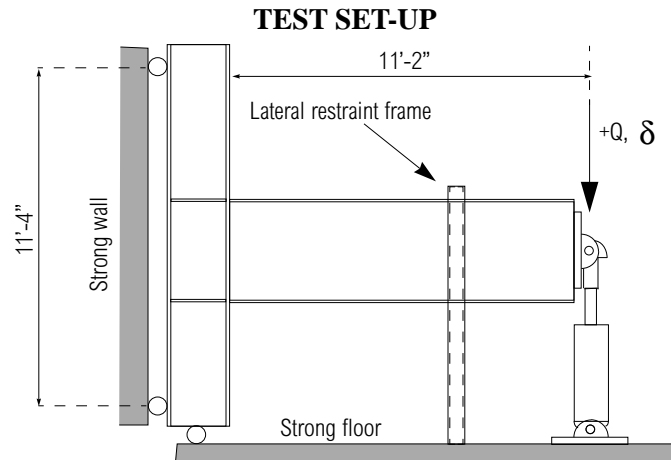
## DISPLACEMENT HISTORY AND KEY EXPERIMENTAL OBSERVATIONS

The standard SAC/ATC-24 loading history was used in the quasi-static testing of the specimen. The yield displacement ( $\delta_y$ ) of the specimen was calculated from nonlinear analysis to be 1.40 in.

Applied Displacement History	Key Observations of the Test	
	Point	Description
	<p><b>1</b></p>	<p><b>2</b></p>
