Specimen ID: UCB-PN1  
 Keywords: Pre-Northridge, simulated field welding, column flange fracture, continuity plate yielding, small rotation capacity  
 Test Location: University of California, Berkeley  
 Test Date: February 9, 1995  
 Principal Investigator: Egor P. Popov; with Marcial Blondet, Lev Stepanov, and B. Stojadinovic  
 Related Summaries: 24  
 Reference: "Experimental Investigations of Beam-Column Subassemblages", *Report No. SAC 96-01*, March 1996.  
 Funding Source: FEMA / SAC Joint Venture, Phase I

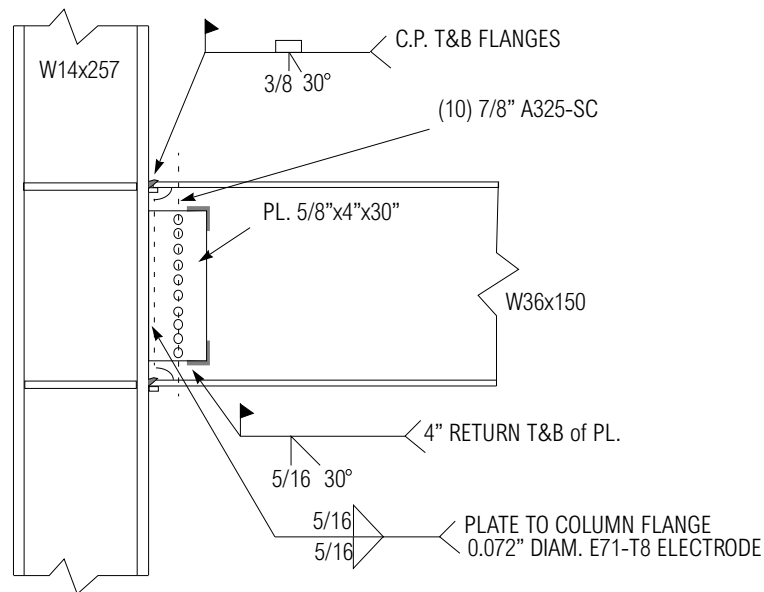
**CONNECTION DETAIL**

Member	Size	Grade	Yield Stress (ksi)		Ultimate Strength (ksi)	
			mill certs.	coupon tests *	mill certs.	coupon tests *
Beam	W36x150	A572 Gr. 50	62.6	60.6 flange 60.1 web	74.7	68.8 flange 69.7 web
Column	W14x257	A572 Gr. 50	53.5	48.3 flange NA web	72.5	67.8 flange 76.1 web
Welding Procedure Specification	All welds FCAW-SS in conformance with AWS D1.1-94, performed with 0.120" diameter AWS E70T-4 electrodes. Preheat and interpass temperature per Table 4.3. Fillet weld of shear tab to beam web performed with 0.072" diameter AWS E71T-8 electrode.					
Shear tab	5/8"x30"x4" plate with ten 7/8" A325 bolts					
Panel zone	No doubler plates					
Continuity plates	1/2" plates with c.p. weld					
Boundary conditions	Single-sided test, no floor slab, axial load in lower half of column equal to shear in beam, specimen tested in flat position					
Other detailing	5/16" fillet weld upper and lower ends of shear tab

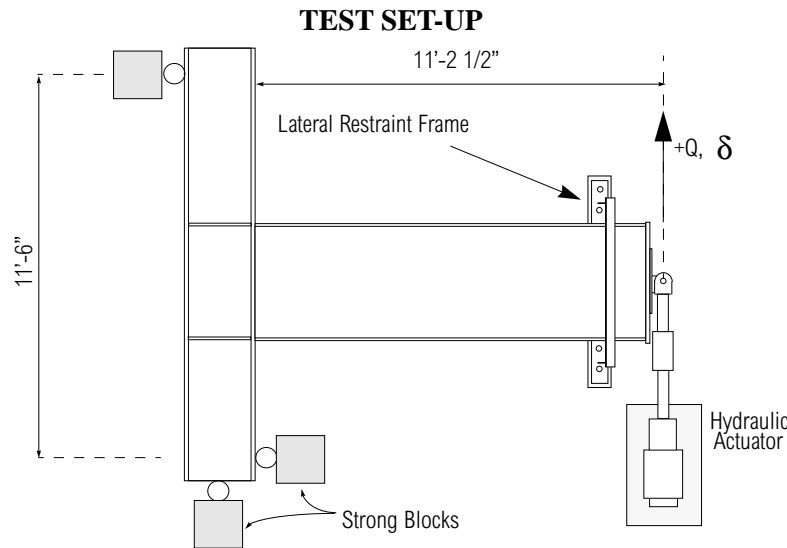
## DISPLACEMENT HISTORY AND KEY EXPERIMENTAL OBSERVATIONS

Applied Displacement History	Key Observations of the Test	
<p style="text-align: center;"><math>\delta_y = 1.0</math> in. (analytical)</p> <p style="text-align: center;">displacement</p> <p style="text-align: center;">3<math>\delta_y</math> 2<math>\delta_y</math> <math>\delta_y</math> -<math>\delta_y</math> -2<math>\delta_y</math> -3<math>\delta_y</math></p>	Point	Description
	1	Yielding of beam top and bottom flanges
	2	Yielding of the back column flange at the continuity plate level
	3	Yielding in the middle of panel zone, slight bolt movement in the shear tab
	4	Fracture of the column flange adjacent to the beam bottom flange through its entire width

Mode of failure: Fracture of the column flange during the second positive excursion to  $3\delta_y$  cycle.

Specimen 10 behaved elastically up to and including the cycles to  $1\delta_y$ . The specimen yielded during the first excursion to  $2\delta_y$ . Yielding was noted on both flanges and on the back column flange at the continuity plate level. Slight yielding was also noted in the panel zone. In addition, slight movement in the shear tab plate due to bolt movement was noted. The specimen failed during the second positive excursion to  $3\delta_y$ . The failure mode was fracture of the column flange through its entire width adjacent to the beam bottom flange. The crack started underneath the backing plate for the beam bottom flange weld. It extended diagonally across the flange to enter the corner of the panel zone. In the panel zone, the crack branched in two directions. One branch extended approximately 8 in. along the continuity plate, and the other branch stretched approximately 10 in. along the column flange. Significant yielding in the column flanges and the lower part of the continuity plate was noted. The maximum plastic rotation of the connection was approximately 0.88% radian, consisting of 0.55% radian from the panel zone, and 0.33% radian from the beam. The failure mode of the specimen with the crack extending throughout the flange width into the column web was observed in several structures after the Northridge earthquake, but this was the first time such a failure had been reproduced in the laboratory. It is likely that the inadvertent overstrength of the beam compared to that assumed in the design (Gr. 50 steel as compared to A36 steel) contributed to this type of failure mechanism.
