Specimen ID: UCB-PN2  
 Keywords: Pre-Northridge, simulated field welding, column flange fracture, continuity plate yielding, small rotation capacity  
 Test Location: University of California, Berkeley  
 Test Date: February 16, 1995  
 Principal Investigator: Egor P. Popov; with Marcial Blondet, Lev Stepanov, and B. Stojadinovic  
 Related Summaries: 25  
 Reference: "Experimental Investigations of Beam-Column Subassemblages", *Report No. SAC 96-01*, March 1996.  
 Funding Source: FEMA / SAC Joint Venture, Phase I

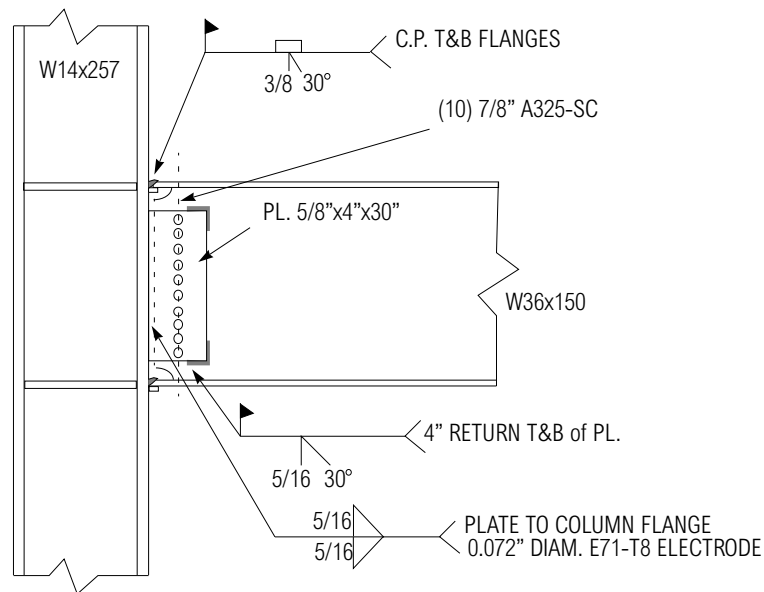
**CONNECTION DETAIL**

Mode of failure: Fracture through the column flange and into the panel zone adjacent to the beam bottom flange during the second positive excursion to  $2\delta_y$  cycle.

Specimen UCB-PN2 exhibited significant panel zone yielding during the first excursion to  $2\delta_y$ . There was little visual evidence of yielding in the beam flanges. In addition, slight movement in the shear tab plate due to bolt slip was noted. The specimen failed suddenly during the second positive excursion to  $2\delta_y$ , at 1.57 in. The failure mode involved fracture through the column flange across its entire width at the bottom beam flange. The crack started in the bottom flange weld, extended diagonally through the column flange, and then climbed upwards along the column flange in the panel zone. The length of the crack was approximately 10 in. The maximum plastic rotation of the connection was approximately 0.34% radian. After failure, the test was continued by completing the  $2\delta_y$  cycles. During the negative excursions, the load carrying capacity dropped by only 4% compared with the cycle recorded prior to the failure, indicating that the crack continued to sustain the applied compression forces. In the positive excursions the load resistance was only 30% of the maximum capacity prior to failure. An additional crack, measuring approximately 4 in. long, opened along the bottom continuity plate, and significant yielding of the lower continuity plate was also noted in these cycles. The failure mode of this specimen is very similar to the observed failure mode of specimen UCB-PN1, described in Test Summary No. 10.
