Specimen ID: UCB-PN3  
 Keywords: Pre-Northridge, simulated field welding, bottom flange fracture, bolt yielding, top flange tear, small rotation capacity  
 Test Location: University of California, Berkeley  
 Test Date: February 27-28, 1995  
 Principal Investigator: Egor P. Popov; with Marcial Blondet, Lev Stepanov, and B. Stojadnovic  
 Related Summaries: 26  
 Reference: "Experimental Investigations of Beam-Column Subassemblages", *Report No. SAC 96-01*, March 1996.  
 Funding Source: FEMA / SAC Joint Venture, Phase I

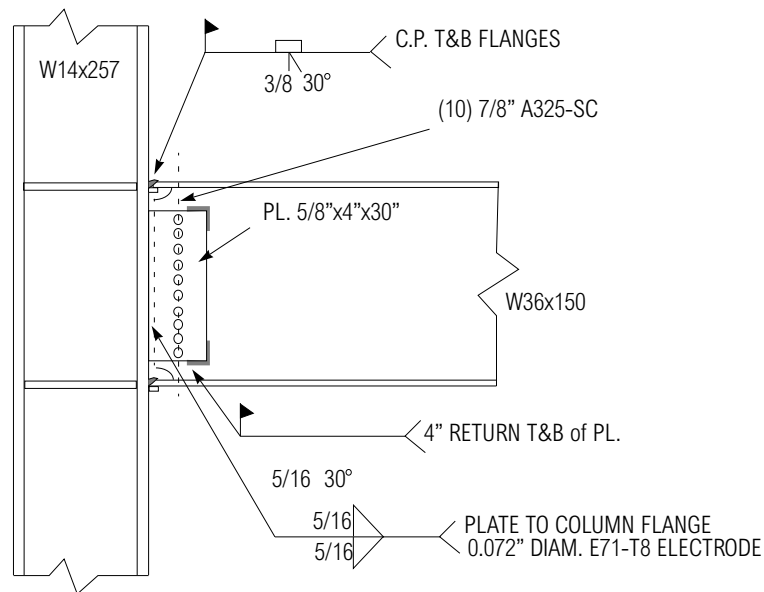
**CONNECTION DETAIL**

Mode of failure: Fracture of the beam bottom flange weld during the second positive excursion to  $3\delta_y$  cycle.

Specimen UCB-PN3 exhibited yielding in both the panel zone and the beam flanges during the first displacement cycle to  $2\delta_y$ . During the  $2\delta_y$  cycles, it was observed that the yield zone in the beam flanges extended approximately 10 in. from the column face. In addition, the shear tab yielded at the top and bottom corners, and slight movement in the shear tab plate due to bolt slip was noted. The specimen failed suddenly during the second positive excursion to  $3\delta_y$ . The beam bottom flange groove weld fractured along the entire flange width. The crack plane coincided with the surface of the column flange. There was virtually no penetration of the crack into the column. The crack may have initiated at the root of the weld. After the weld fracture, the shear tab bent and tore along the bolt line, shearing the bottom three bolts. Yielding of the beam flanges extended approximately 18" from the face of the column. The test was continued until two  $3\delta_y$  cycles were completed. During the negative excursion, the groove weld of the top flange of the beam began to tear starting at the edge of the flange and extending 9 in. During the negative excursions, the specimen capacity was 65% of its maximum prior to the failure. The failure at the top flange weld also induced a crack at the top of the shear tab. Prior to failure, the maximum plastic rotation of joint was approximately 1.07% radian.
