Specimen ID: EERC-RN1
 Keywords: Repaired work, notch-tough electrode material, panel zone yielding, weld fracture, small rotation capacity
 Test Location: Earthquake Engineering Research Center
 Test Date: July 10, 1995
 Principal Investigator: Vitelmo V. Bertero; with Andrew S. Whittaker and Amir S. Gilani
 Related Summaries: 1, 14
 Reference: "Experimental Investigations of Beam-Column Subassemblages", *Report No. SAC 96-01*, March 1996.
 Funding Source: FEMA / SAC Joint Venture, Phase I

CONNECTION DETAIL

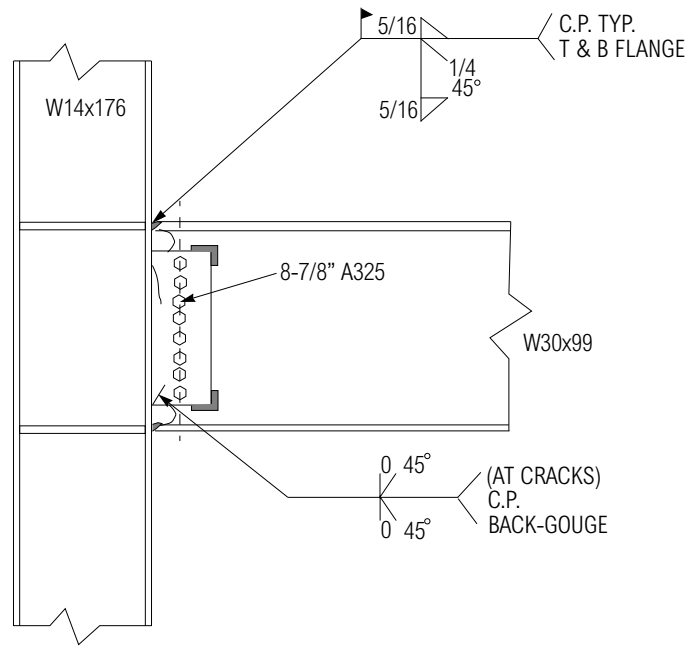
This was a test of repairs on specimen EERC-PN1 (Test Summary No. 1) that was originally tested on March 7, 1995. The original specimen experienced a sudden fracture through the top beam flange to column flange weld before undergoing any significant plastic deformations or rotations. The failure began during the first displacement excursion to $3\delta_y$ (where $\delta_y = 1.40$ in. was obtained from analytical studies of the original specimen). The failure of the specimen was preceded by shear yielding in the panel zone, first observed during the displacement cycles to $0.75\delta_y$. Visual observation of the specimen following testing suggested that there was little plastification in the beam. The cyclic tests were performed quasi-statically.

The specimen repair procedure consisted of realigning the beam-column assembly to 90 degrees, removing the fractured top flange weld material and replacing it with a complete penetration groove weld composed of notch-tough filler metal (AWS E71T-8), removing the back-up bars from the underside of both beam flanges, back-gouging the root pass of the groove welds, and placing fillet welds in the back-gouged zones to reinforce the groove welds, and welding cracks that had formed in the shear tab. The standard SAC/ATC-24 loading history was used in the quasi-static testing of the repaired specimen.

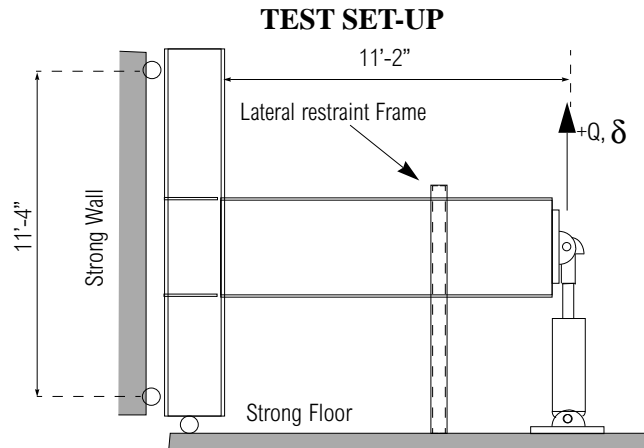
DISPLACEMENT HISTORY AND KEY EXPERIMENTAL OBSERVATIONS

Applied Displacement History	Key Observations of the Test	
	Point	Description
	1	Shear yielding in the panel zone
	2	Local buckling of beam top flange
3	Fracture of welded connection of beam bottom flange to column flange

Mode of failure: Fracture of the beam bottom flange groove weld during the second positive $2\delta_y$ cycle.

Specimen EERC-RN1 failed during the second positive displacement excursion to $2\delta_y$. The groove welded connection between the beam bottom flange and the column flange fractured at a beam tip displacement of approximately 2.6 in. Failure of the specimen was preceded by shear yielding in the panel zone, first observed during the first displacement cycle to $1\delta_y$. Minor buckling of the top flange adjacent to the column was observed during the first positive displacement excursion to $2\delta_y$. The specimen failed abruptly during the next positive displacement cycle. Data from the strain gages on the underside of the bottom flange of the beam indicated that the failure was likely initiated at the edges of the flange out-stands and propagated in toward the beam web. There was little evidence of yielding in the beam. The maximum plastic rotation of the connection prior to failure was approximately 0.011 radian, consisting of 0.008 radian from the panel zone, and 0.003 radian from the beam. The beam plastic rotations for this specimen were smaller than those measured for the original specimen. As in the original specimen, the panel zone dissipated substantially more energy than the beam.
