Specimen ID: EERC-RN1A  
 Keywords: Repair, notch-tough electrode material, panel zone yielding, weld fracture, small rotation capacity  
 Test Location: Earthquake Engineering Research Center, University of California at Berkeley  
 Test Date: August 8, 1995  
 Principal Investigator: Vitelmo V. Bertero; with Andrew S. Whittaker and Amir S. Gilani  
 Related Summaries: 1, 13  
 Reference: "Experimental Investigations of Beam-Column Subassemblages", *Report No. SAC 96-01*, March 1996.  
 Funding Source: FEMA / SAC Joint Venture, Phase I

**CONNECTION DETAIL**

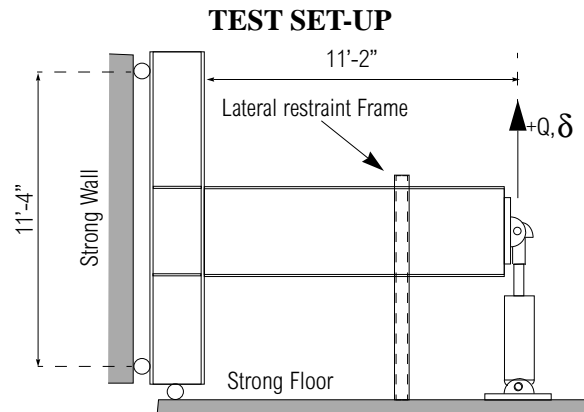
Applied Displacement History	Key Observations of the Test	
<p style="text-align: center;"><math>\delta_y = 1.4</math> in. (analytical)</p>	Point	Description
	1	Shear yielding in the panel zone
	2	Fracture of the welded connection between the beam bottom flange and the column flange

Mode of failure: Fracture of the groove weld between the beam bottom flange and the column flange during the first positive displacement excursion to  $3\delta_y$  cycle.

Specimen EERC-RN1A failed during the first positive displacement excursion to  $3\delta_y$ . The groove weld between the beam bottom flange and the column flange fractured at a beam tip displacement of approximately 3.0 in. Failure of the specimen was preceded by shear yielding in the panel zone, first observed during the first displacement cycle to  $1\delta_y$ . Visual inspection of the underside of the bottom flange of the beam indicated that the failure was likely initiated at the underside of the beam web and propagated out towards the edges of the flange. There was little evidence of yielding in the beam. The maximum plastic rotation of the connection prior to failure was approximately 0.010 radian, consisting of 0.007 radian from the panel zone, and 0.003 radian from the beam. The beam plastic rotations for this specimen were of the same order of magnitude of the original and the first repaired specimen, even though notch-tough electrodes were used in both beam flange-to-column flange welds. Therefore, the results of the test do not provide evidence that the use of notch-tough electrode material will enhance the seismic performance of the beam-column connections.
