Specimen ID: EERC-RN2
 Keywords: Repair, top and bottom triangular haunch, beam flange not welded, flange local buckling, web distortion, large strains, medium rotation capacity
 Test Location: Earthquake Engineering Research Center, University of California at Berkeley
 Test Date: June 29-30, 1995
 Principal Investigator: Vitelmo V. Bertero; with Andrew S. Whittaker and Amir S. Gilani
 Related Summaries: 2
 Reference: "Experimental Investigations of Beam-Column Subassemblages", Report No. SAC 96-01, March 1996.
 Funding Source: FEMA / SAC Joint Venture, Phase I

MATERIAL PROPERTIES AND SPECIMEN DETAILS

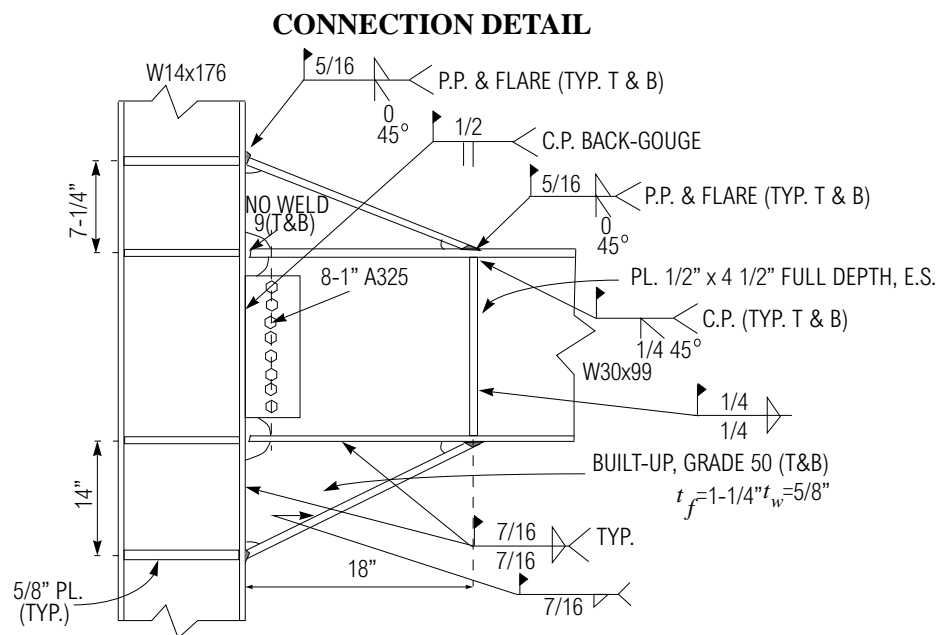
This was a test of repairs to specimen EERC-PN2 (Test Summary No. 2) that was originally tested on March 14-15, 1995. The original specimen failed when the weld between the beam top flange and the column flange fractured prior to undergoing any significant plastic deformations or rotations. The fracture occurred during the third negative displacement excursion to $2\delta_y$, (where, $\delta_y = 1.40$ in., was obtained from analytical studies of the original specimen). The failure of the specimen was preceded by shear yielding in the panel zone, first observed during the displacement cycles to $0.75\delta_y$. Visual observation of the specimen following testing suggested that the beam did not yield over its full depth. The cyclic tests were performed quasi-statically.

Other detailing	Existing top and bottom flange groove welds removed; CJP groove welds applied between haunch flanges and beam and column flanges, backup bars removed, weld back-gouged, reinforcing fillets added

The specimen repair procedure consisted of realigning of the beam column assembly to 90 degrees, removing the fractured top flange weld material, removing the undamaged bottom flange weld material, adding built-up T-shaped top and bottom haunches at the beam-column connections, groove welding the haunch flanges to the beam and column and fillet welding of the haunch webs to the beam and column, back-gouging the root pass of the groove welds and placing reinforcing fillet welds in the back-gouged zones, groove welding the beam web to the column flange, and installing additional continuity plates and vertical web stiffeners. The standard SAC/ATC-24 loading history was used in the quasi-static testing of the repaired specimen.

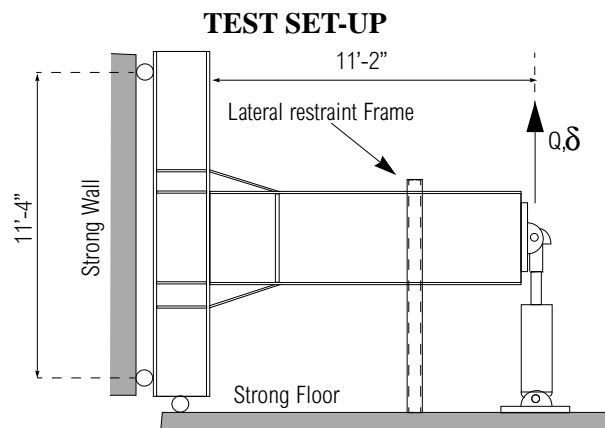
Applied Displacement History	Key Observations of the Test	
	Point	Description
	1	Local buckling in beam bottom flange outside of haunch
	2	Local buckling in beam top flange outside of haunch
	3	Peak load in this cycle was less than 80% of the previous maximum load
	4	Substantial local buckling and web distortion in the beam top flange adjacent to the haunch
	5	Fracture of beam top flange, with the crack propagating into the beam web

Mode of failure: The load-carrying capacity of the specimen dropped below 80% of the recorded maximum load during the displacement cycles to $3\delta_y$ due to local buckling of the beam flanges outside of the haunch. Fracture of the beam top flange due to severe local buckling was observed in subsequent cycles.

The capacity of specimen EERC-RN2 dropped below 80 percent of its maximum during the third negative displacement cycle to $3\delta_y$. At the peaks of the cycles, the amplitude of flange buckling was approximately 2.5 in. Although there were no material or weld fractures observed at this displacement, such a loss of load carrying capacity was specified as failure according to the SAC Phase 1 test protocol. However, the test was continued, and the beam ultimately developed a plastic rotation of 0.06 radian during the cycles to $5\delta_y$, but with a reduction in the load carrying capacity of approximately 50 percent. The material fracture resulted from substantial local buckling of the beam flanges just outside the haunch zone. The fracture of the top flange of the specimen occurred at a displacement of approximately -5.5 in. during the third negative displacement excursion to $5\delta_y$. The fracture was likely caused by high strains resulting from large curvatures in the buckled flange. The maximum moment delivered to the column was 36 percent higher than in the original specimen. The maximum plastic rotation of the connection prior to the 20 percent drop in load-carrying capacity used to define failure was approximately 0.028 radian, consisting of 0.001 radian from the panel zone, and 0.027 radian from the beam. The beam plastic rotations for this specimen were much larger compared to the original specimen.
