Specimen ID: EERC-RN3
 Keywords: Repair, top and bottom triangular haunch, weld beam web to column, flange local buckling, web distortion, large strains, medium rotation capacity
 Test Location: Earthquake Engineering Research Center, University of California at Berkeley
 Test Date: June 23, 1995
 Principal Investigator: Vitelmo V. Bertero; with Andrew S. Whittaker and Amir S. Gilani
 Related Summaries: 3
 Reference: "Experimental Investigations of Beam-Column Subassemblages", Report No. SAC 96-01, March 1996.
 Funding Source: FEMA / SAC Joint Venture, Phase I

MATERIAL PROPERTIES AND SPECIMEN DETAILS

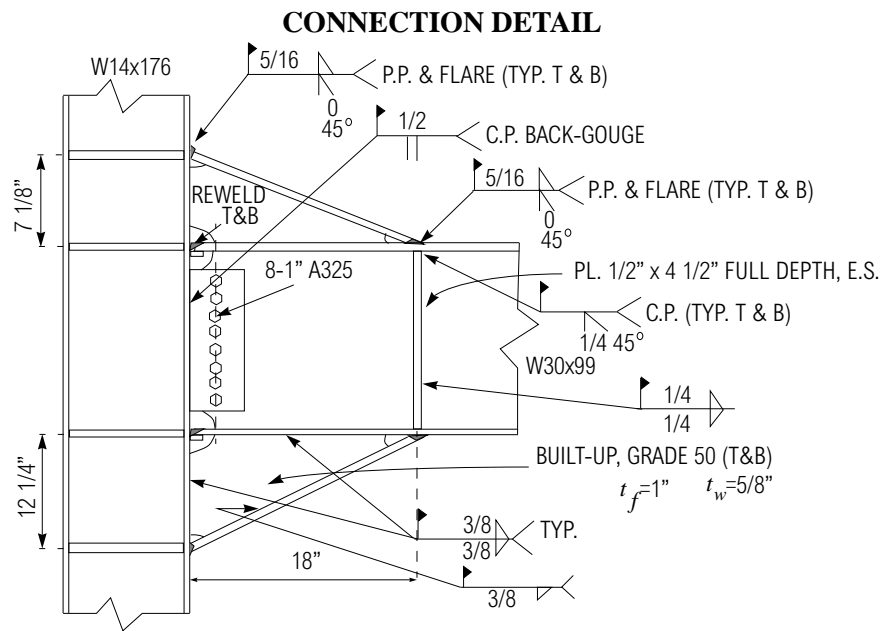
Other detailing	Fractured top and bottom beam flange-to-column flange welds removed and replaced with new CJP groove welds; CJP groove welds applied between haunch flanges and beam and column flanges; backup bars removed from all groove welds, welds back-gouged, reinforcing fillets added

This was a test of repairs to specimen EERC-PN3 (Test Summary No. 3) that was originally tested on March 29-30, 1995. The original specimen failed when the weld between the beam top flange and the column flange fractured during the second negative displacement excursion to $3\delta_y$, (where, $\delta_y = 1.40$ in., was obtained from analytical studies of the original specimen). The failure occurred at a beam tip displacement of approximately -3.3 in; the plastic rotation of the connection was approximately 2.1% radian. The failure of the specimen was preceded by shear yielding in the panel zone, first observed during the displacement cycles to $0.75\delta_y$. Pronounced buckling of both beam flanges was observed prior to the weld fracture. The cyclic tests were performed quasi-statically.

The specimen repair procedure consisted of realigning the beam column assembly to 90 degrees, removing the fractured flange weld material, reconstructing the groove welded flange connections using notch-tough electrode material, adding built-up T-shaped top and bottom haunches at the beam-column connections, groove welding the haunch flanges and fillet welding the haunch webs to the beam and column flanges, back-gouging the root pass of the groove welds and placing reinforcing fillet welds in the back-gouged zones, groove welding the beam web to the column flange, and installing additional continuity plates and vertical stiffeners. The standard SAC/ATC-24 loading history was used in the quasi-static testing of the repaired specimen.

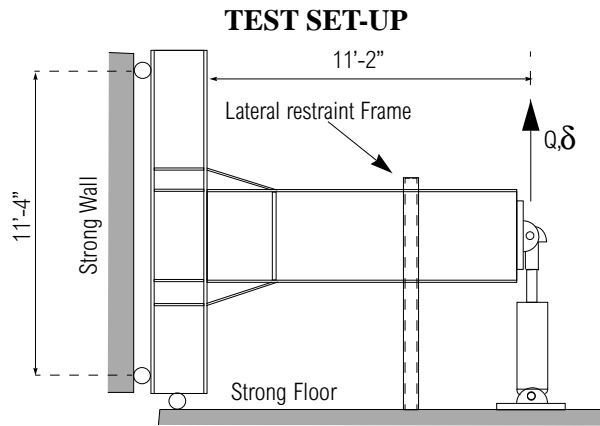
Applied Displacement History	Key Observations of the Test	
	Point	Description
	1	Local buckling in beam top flange outside of haunch
	2	Local buckling in beam bottom flange outside of haunch
	3	Maximum load reduced below 80% maximum
	4	Substantial beam flange local buckling and web distortion
5	Fracture of beam top flange

Mode of failure: The load-carrying capacity of the specimen dropped below 80% of the recorded maximum load during the displacement cycles to 3 due to local buckling of the beam flanges outside of the haunch. Fracture of the beam top flange due to severe local buckling was observed in subsequent cycles.
