Specimen ID: UCSD-1R
 Keywords: Repaired, bottom haunch, unconnected beam bottom flange, local and lateral torsional buckling, haunch yielding, medium rotation capacity
 Test Location: University of California, San Diego
 Test Date: March 31, 1995
 Principal Investigator: Chia-Ming Uang; with Duane Bondad
 Related Summaries: 4
 Reference: "Experimental Investigations of Beam-Column Subassemblages", Report No. SAC 96-01, March 1996.
 Funding Source: FEMA / SAC Joint Venture, Phase I

BACKGROUND

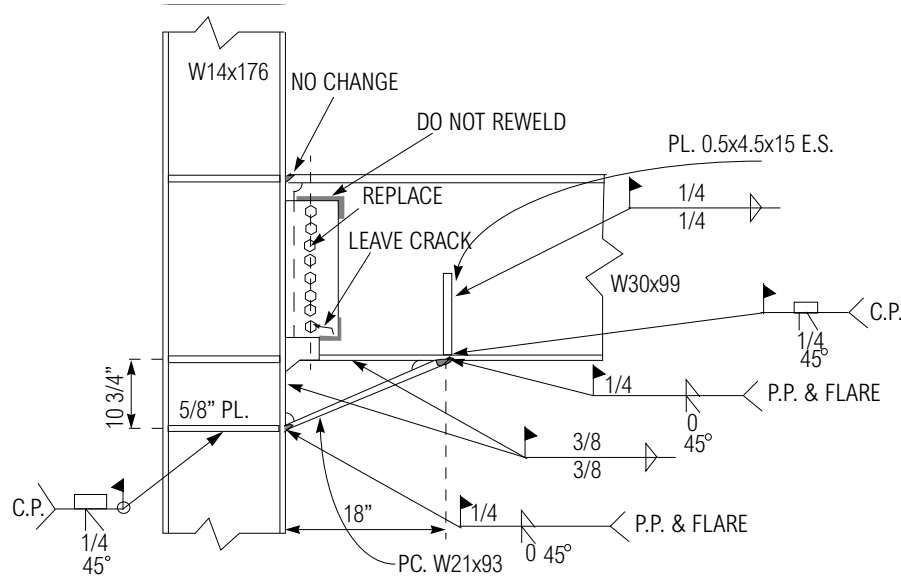
CONNECTION DETAIL

Boundary conditions	Single-sided test, no floor slab, axial load in lower half of column equal to shear in beam, specimen tested in upright position					
Other detailing	Bottom beam flange not welded to column flange

The objective of adding a haunch to the connection was to force plastic hinging in the beam to occur away from the column face. The specimen repair procedure consisted of realigning the connection to 90 degrees, replacing of the shear tab bolts, removal of the beam bottom flange from the column face to the back of the access hole, installing a haunch (cut from W21x93) by welding the haunch flange to the column and beam flanges and fillet welding the haunch webs to the column and beam flanges, installing an additional continuity plate at the haunch level, and installing a vertical stiffener at the end of the haunch extending halfway through the beam depth. The beam top flange was not repaired or strengthened, because ultrasonic tests revealed no unacceptable defects. The standard SAC/ATC-24 loading history was used in the quasi-static testing of the repaired specimen, and a yield displacement (δ_y) of 1.40 in. was assumed to provide the consistency with previous tests.
