Specimen ID: UCSD-3R
 Keywords: Repaired, replacement top plate, bottom haunch, beam web to column weld, local buckling, increased energy dissipation, medium rotation capacity
 Test Location: University of California, San Diego
 Test Date: April 28, 1995
 Principal Investigator: Chia-Ming Uang; with Duane Bondad
 Related Summaries: 6
 Reference: "Experimental Investigations of Beam-Column Subassemblages", Report No. SAC 96-01, March 1996.
 Funding Source: FEMA / SAC Joint Venture, Phase I

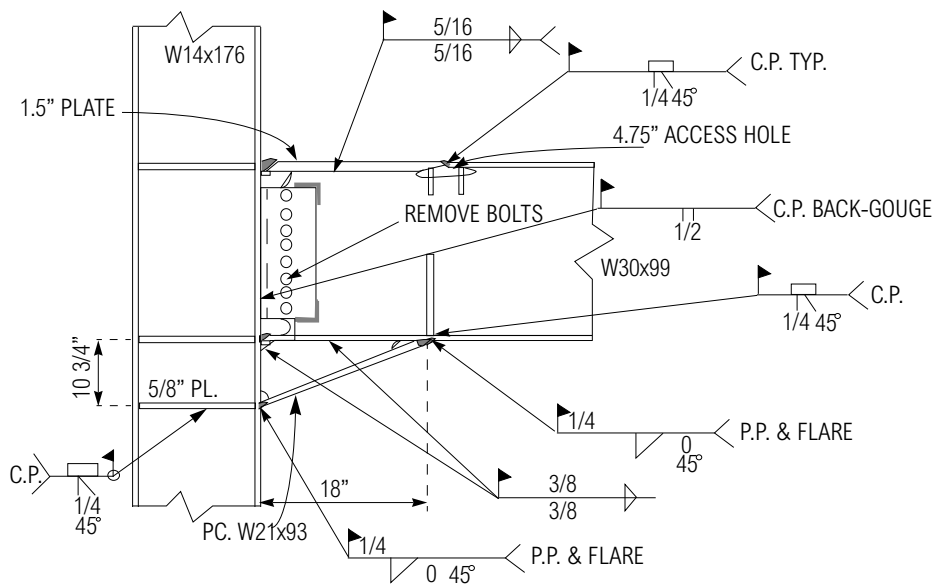
CONNECTION DETAIL

Member	Size	Grade	Yield Stress (ksi)		Ultimate Strength (ksi)	
			mill certs.	coupon tests *	mill certs.	coupon tests *
Beam	W30X99	A36	49.3	46.5 flange 57.1 web	71.8	67.7 flange 72.5 web
Column	W14X176	A572 Gr. 50	55.0	52.5 flange 51.2 web	74.5	68.2 flange 67.2 web
Haunch	W21X93	A36	N.A.	39.0 flange 39.8 web	N.A.	64.0 flange 69.2 web
Vertical Stiffener	1/2" plate	A36	N.A.	45.2	N.A.	66.9
Replacement Plate	1 1/2" plate	A36	N.A.	42.2	N.A.	71.4
Welding Procedure Specification	All welds FCAW-SS in conformance with AWS D1.1-94, performed with 0.120" diameter AWS E70T-4 electrodes. Preheat and interpass temperature per Table 4.3. Fillet weld of shear tab to beam web performed with 0.072" diameter AWS E71T-8 electrode. All repairs performed using 0.072 in. diameter AWS E71-T8 electrode.					
Shear tab	3/8 x 5" plate, remove bolts, groove weld beam web to column flange					
Panel zone	No doubler plates

Continuity plates	3/8" plates with c.p. weld ; add a 5/8" plate at the haunch level with 1/4" c.p. weld					
Boundary conditions	Single-sided test, no floor slab, axial load in lower half of column equal to shear in beam, specimen tested in upright position					
Other detailing	Repair beam bottom flange groove weld, add vertical stiffeners at replacement plate access hole

The specimen repair procedure consisted of torch cutting and removing a 20-in. long portion of the beam top flange, torching a 4.75 in. wide inclined access hole, replacing the cut beam top flange with a 1.5" thick plate, welding the replacement plate to the column and beam flanges, fillet welding the plate to the beam web, removing the backup bars and running a final weld pass, welding 4" vertical stiffeners at the access hole, removing the shear tab bolts, groove welding the beam web to the column flange, welding the flange of the haunch to the column and beam flanges, fillet welding the haunch web to the column and beam flanges, installing additional horizontal continuity plates, and installing vertical stiffener plates. The objective of this repair scheme was to force plastic hinging in the beam to occur away from the column face. The standard SAC/ATC-24 loading history was used in the quasi-static testing of the repaired specimen, and a yield displacement (δ_y) of 1.40 in. was assumed to provide consistency with the previous test.
