Specimen ID: EERC-PN2
 Keywords: Pre-Northridge, simulated field welding, panel zone yielding, weld fracture, small rotation capacity
 Test Location: Earthquake Engineering Research Center, University of California at Berkeley
 Test Date: March 14-15, 1995
 Principal Investigator: Vitelmo V. Bertero; with Andrew S. Whittaker and Amir S. Gilani
 Related Summaries: 15
 Reference: "Experimental Investigations of Beam-Column Subassemblages," *Report No. SAC 96-01*, March 1996.
 Funding Source: FEMA / SAC Joint Venture, Phase I

MATERIAL PROPERTIES AND SPECIMEN DETAILS

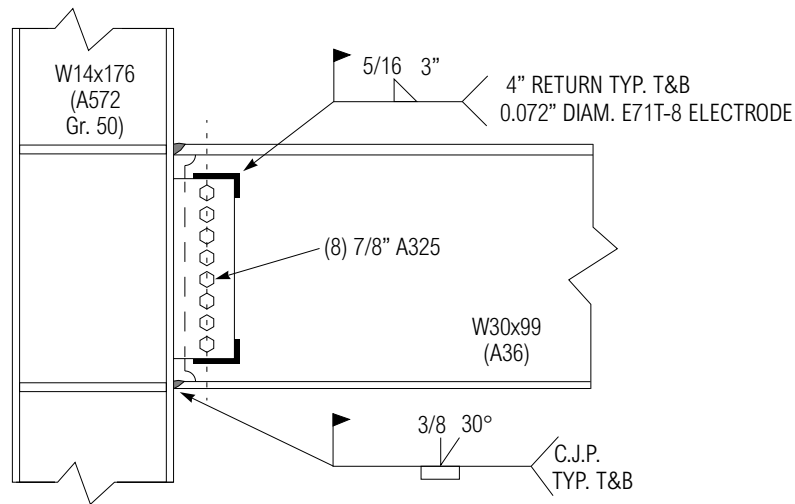
CONNECTION DETAIL

Member	Size	Grade	Yield Stress (ksi)		Ultimate Strength (ksi)	
			mill certs.	coupon tests*	mill certs.	coupon tests*
Beam	W30X99	A36	54.1	48.6 flange 57.4web	73.4	70.9 flange 72.9 web
Column	W14X176	A572 Gr. 50	56.5	48.6 flange 53.5web	74.5	68.9 flange 70.8web
Welding Procedure Specification	All welds FCAW-SS in conformance with AWS D1.1-94, performed with 0.120" diameter AWS E70T-4 electrodes. Preheat and interpass temperature per Table 4.3. Fillet weld of shear tab to beam web performed with 0.072" diameter AWS E71T-8 electrode.					
Shear tab	1/2" x 4-1/2" x 23-5/8" plate with eight 7/8" A325 bolts					
Panel zone	No doubler plates					
Continuity plates	3/8" plates with CJP groove weld					
Boundary conditions	Single-sided test, no floor slab, axial load in lower half of column equal to shear in beam, specimen tested in upright position					
Other detailing	Connection between column and beam welded in the upright position

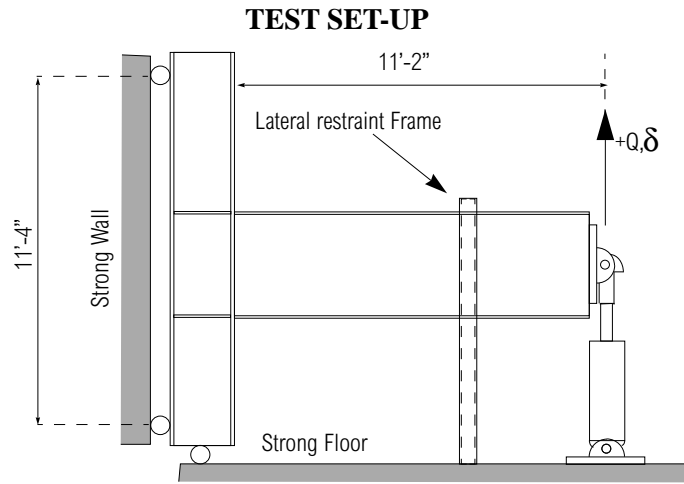
DISPLACEMENT HISTORY AND KEY EXPERIMENTAL OBSERVATIONS

The standard SAC/ATC-24 loading history was used in the quasi-static testing of the specimen. The yield displacement (δ_y) of the specimen was calculated from nonlinear analysis to be 1.40 in.

Applied Displacement History	Key Observations of the Test	
	Point	Description
	1	Shear yielding in the panel zone (displacement = $0.75 \delta_y$)
	2	Fracture of welded connection of beam top flange to column flange

Mode of failure: Fracture of the welded beam top flange to column flange connection during the third $2\delta_y$ cycle.

Specimen EERC-PN2 failed during the first half-cycle of the third displacement excursion to $2\delta_y$. Failure of the groove welded connection of the beam top flange to the column flange occurred at a beam tip displacement of approximately -2.1 in. during this excursion. Failure of the specimen was preceded by shear yielding in the panel zone, first observed during the first displacement cycle to $0.75\delta_y$. The specimen failed abruptly during the $2\delta_y$ cycle. Visual inspection of the specimen following the testing suggest that there was little plastification in the beam. The maximum plastic rotation of the connection prior to failure was approximately 1.1% radian: 0.7% radian in the panel zone, and 0.4% radian in the beam. The panel zone dissipated substantially more energy than the beam.
