Specimen ID: UTA-1R
 Keywords: Repair, bottom haunch, beam and column splice plates, web doubler plate, flange and web yielding, top weld fracture, medium rotation capacity
 Test Location: University of Texas, Austin
 Test Date: October 20, 1995
 Principal Investigator: Michael D. Englehardt; with Bradley D. Shuey and Thomas A. Sabol
 Related Summaries: 7, 21
 Reference: "Experimental Investigations of Beam-Column Subassemblages", *Report No. SAC 96-01*, March 1996.
 Funding Source: FEMA / SAC Joint Venture, Phase I

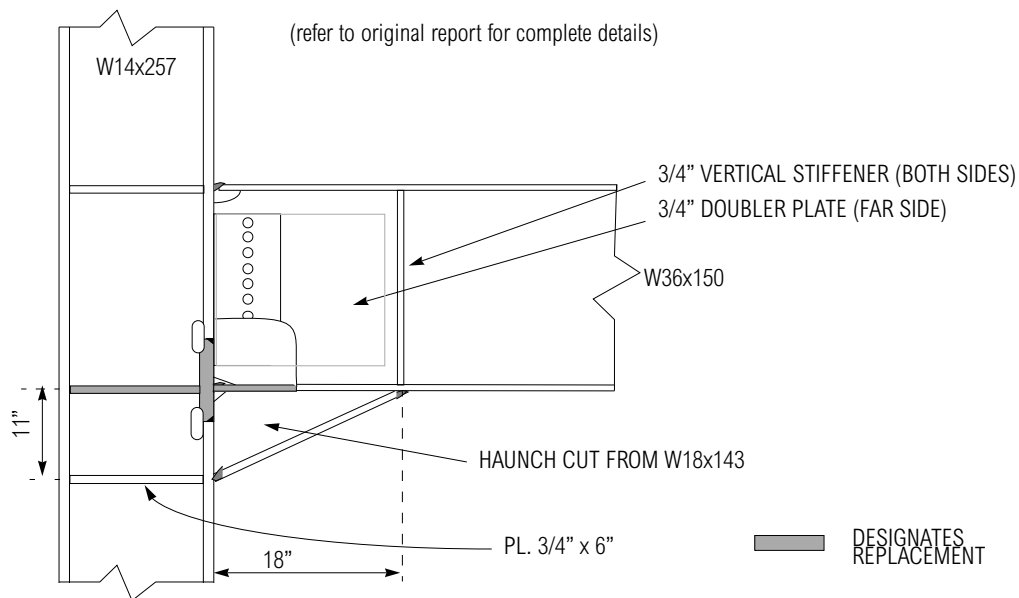
CONNECTION DETAIL

Boundary conditions	Single-sided test, no floor slab, axial force in lower half of column equal to beam shear force, specimen tested in upright position					
Other detailing	Backup bars removed at top flange, weld root back-gouged and replaced

The repair procedure included, cutting an access hole in the beam bottom flange, removing the bottom continuity plate, cutting column web access holes, removing the damaged portion of the column flange and replacing it with a new plate, installing new continuity plates, installing new material at the beam bottom flange, removing the shear tab bolts, installing a web doubler plate on the beam side opposite the shear tab, installing a bottom haunch, installing vertical beam stiffeners at the end of the haunch, and repairing the root of the top weld. The displacement loading history followed the standard SAC/ATC-24 protocol. A yield displacement (δ_y) of 1.0 in. was assumed for the repaired specimen to be consistent with that used in the test of the original specimen.

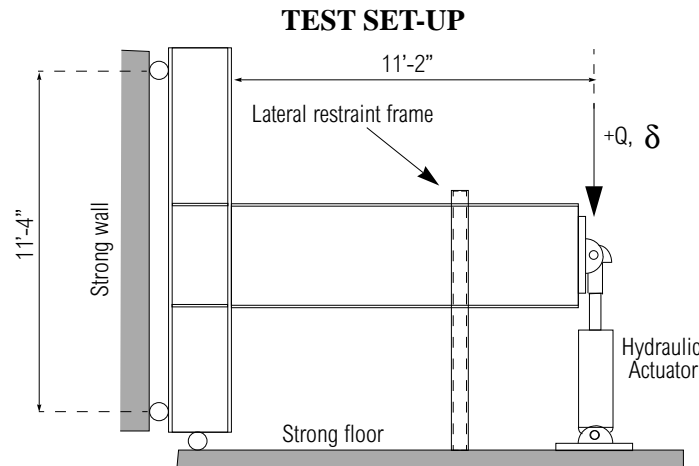
DISPLACEMENT HISTORY AND KEY EXPERIMENTAL OBSERVATIONS

Applied Displacement History	Key Observations of the Test	
	Point	Description
	1	Yielding of beam flanges outside the haunch
	2	Increased beam flange yielding, panel zone yielding, beam web yielding
	3	Column rear flange yielding, slight buckling in beam top flange and beam web
	4	Substantial top flange buckling, slight bottom flange buckling
	5	Failure of original top shear tab supplemental weld
6	Fracture through weld at beam top flange to column connection

Mode of failure: Fracture through weld at the beam top flange to column connection during the $4\delta_y$ displacement cycle.

Specimen UTA-1R failed in the second half of the second displacement cycle to $4\delta_y$ at a tip displacement of -0.21 in. Failure occurred when a sudden fracture developed at the beam top flange to column weld. Initial yielding occurred during the $0.75\delta_y$ cycles in the beam flanges outside the haunch region. The yielding pattern continued during the $1\delta_y$ and $2\delta_y$ cycles. At the bottom flange, yielding developed only outside the haunch face. At the top flange, it progressed into the haunch region. During the $2\delta_y$ cycles, panel zone yielding and beam web yielding outside the haunch-stiffener region was noted. The onset of beam flange local buckling, yielding of the rear column flange, and visible column joint rotation was observed during the $3\delta_y$ cycles. The buckling in the beam occurred outside of the haunch/stiffener region and became more severe in both the web and flanges during the $4\delta_y$ cycles. During the second $4\delta_y$ cycle, sudden fracture of the original top shear tab supplemental weld preceded the fracture across the beam top flange weld. The maximum plastic rotation of the connection was approximately 2.2% radian.
