Specimen ID: UTA-1RB  
 Keywords: Bottom haunch, top cover plate, web doubler plate, replacement plates, beam flange and web buckling, column bowing, specimen twisting  
 Test Location: University of Texas, Austin  
 Test Date: November 10, 1995  
 Principal Investigator: Michael D. Englehardt; with Bradley D. Shuey and Thomas A. Sabol  
 Related Summaries: 7, 20  
 Reference: "Experimental Investigations of Beam-Column Subassemblages", Report No. SAC 96-01, March 1996.  
 Funding Source: FEMA / SAC Joint Venture, Phase I

### CONNECTION DETAIL

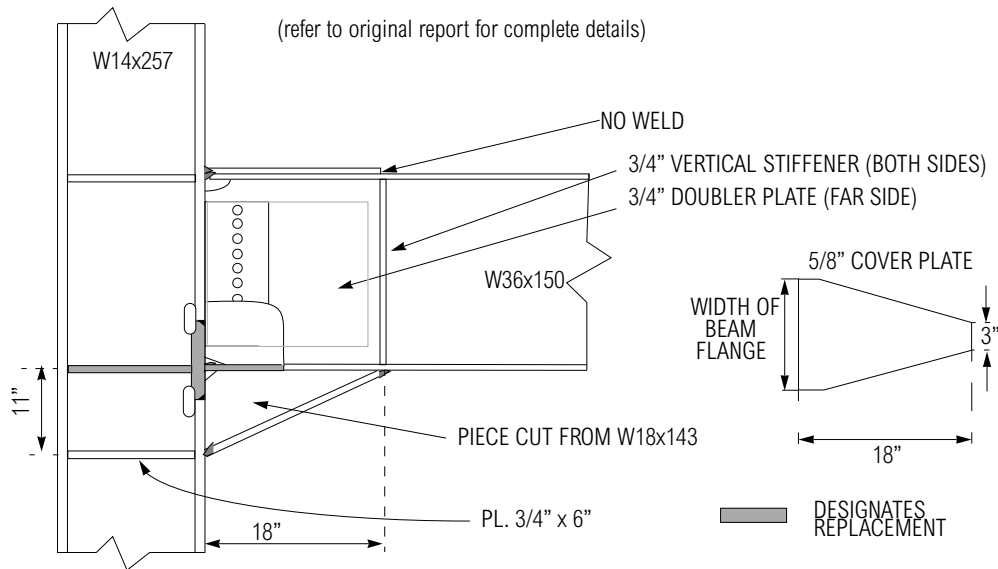
Boundary conditions	Single-sided test, no floor slab, axial force in lower half of column equal to beam shear force, specimen tested in upright position					
Other detailing	CJP replacement weld at top flange performed prior to installation of cover plate; no fillet weld at end of cover plate, remove weld tabs

The repair schedule consisted of back-gouging and removing the existing beam top flange weld material, grinding the surface smooth, welding the beam top flange to the column flange, back-gouging the root to sound metal and removing the weld tabs, welding the cover plate to the column flange, and fillet welding the cover plate to the beam top flange.

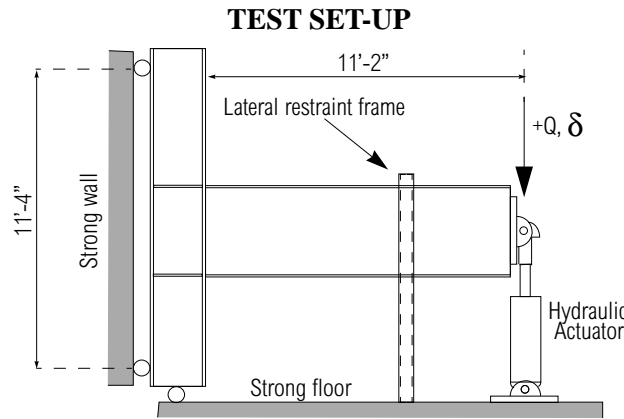
## DISPLACEMENT HISTORY AND KEY EXPERIMENTAL OBSERVATIONS

Applied Displacement History	Key Observations of the Test	
	Point	Description
	1	Buckling of beam top flange
	2	Increased buckling of beam top flange
	3	Beam web buckling, panel zone yielding, and slight column bending
	4	Beam top and bottom flange buckling; increased panel zone yielding, column bending; slight twisting in bottom haunch
	5	Severe top flange buckling, top continuity plate buckling, column bending and twisting
	6	Termination of testing due to severe lateral torsional buckling of the specimen at the face of the haunch
