Specimen ID: UTA-2R
 Keywords: Repair, beam and column splice plates, web doubler plate, vertical stiffeners
 beam and web doubler plate connection fractures, low rotation capacity
 Test Location: University of Texas, Austin
 Test Date: October 4, 1995
 Principal Investigator: Michael D. Englehardt; with Bradley D. Shuey and Thomas A. Sabol
 Related Summaries: 8
 Reference: "Experimental Investigations of Beam-Column Subassemblages", *Report No. SAC 96-01*, March 1996.
 Funding Source: FEMA / SAC Joint Venture, Phase I

CONNECTION DETAIL

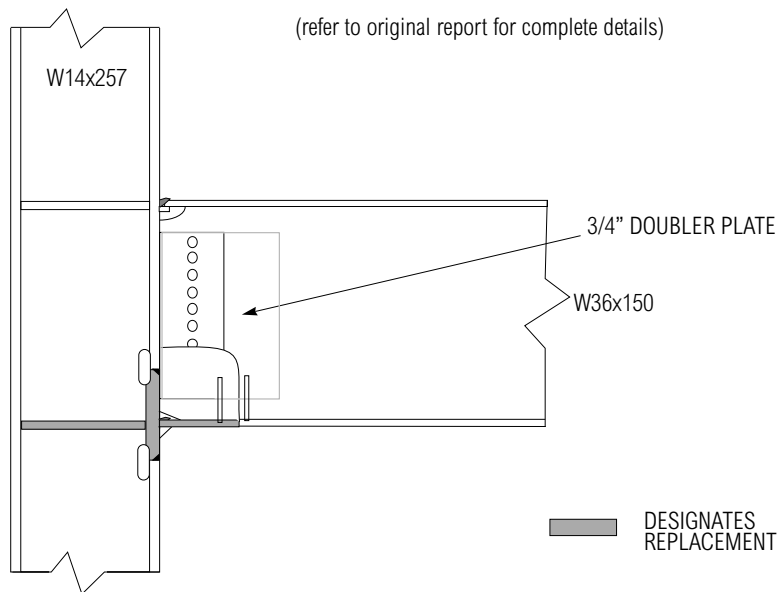
This was a test of a repairs to specimen UTA-2 (Test Summary No. 8) which was originally tested on March 24, 1995. The original specimen failed in the first half of the second displacement cycle to $2\delta_y$ without undergoing any significant plastic deformation. Both halves of the bottom flange connection experienced separate divot fractures into the column flange.

The repair schedule consisted of removing the beam material adjacent to the fractured weld, removing the existing bottom continuity plate, cutting two column web access holes, removing a piece of the column flange where the divot fractures had occurred, removing the shear tab bolts, inserting a new plate as a column flange splice, welding the column splice plate to the column flange and web, installing a new continuity plate, inserting a beam flange splice plate, welding the beam flange splice plate to the column flange splice plate and to the existing beam flange, removing all weld tabs, installing a web doubler plate on the side of the beam opposite the existing shear tab and welding this to column the flange and the beam bottom flange splice plate and beam web, and installing short vertical beam web stiffeners. The displacement history followed the standard SAC/ATC-24 protocol. The reference displacement (δ_y) was selected to be 1.00 in. to be consistent with that used in the original test.
