Specimen ID: UTA-3R  
 Keywords: Repaired, top and bottom haunch, web doubler plate, flange and web buckling, specimen twisting, medium rotation capacity  
 Test Location: University of Texas, Austin  
 Test Date: November 8, 1995  
 Principal Investigator: Michael D. Englehardt; with Bradley D. Shuey and Timothy Portyaj  
 Related Summaries: 9  
 Reference: "Experimental Investigations of Beam-Column Subassemblages", *Report No. SAC 96-01*, March 1996.  
 Funding Source: FEMA / SAC Joint Venture, Phase I

**MATERIAL PROPERTIES AND SPECIMEN DETAILS**

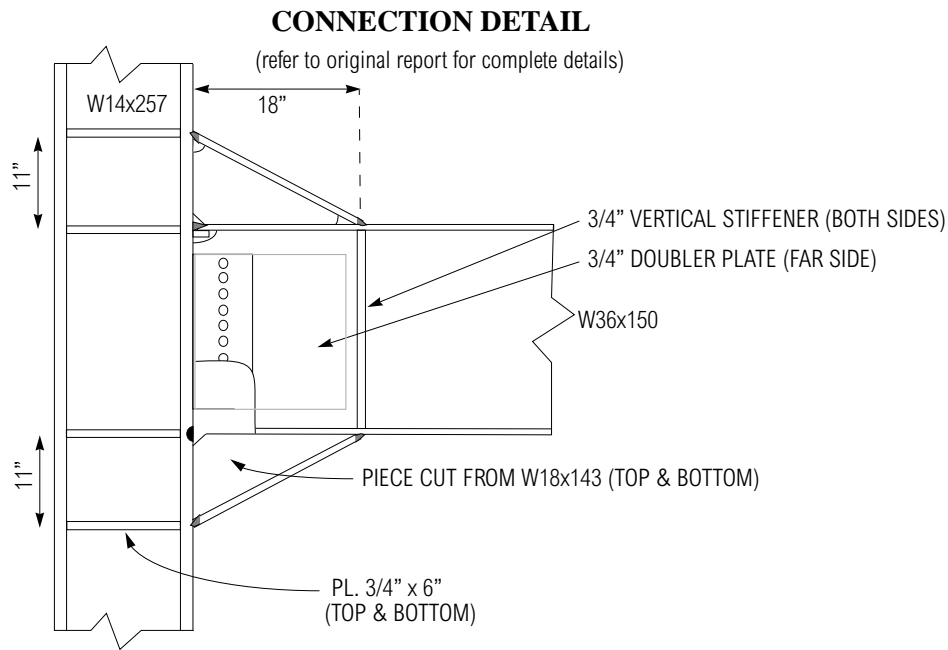
Other detailing	Beam bottom flange not rewelded to the column flange, no repairs to top flange

This was a test of repairs to specimen UTA-3 (Test Summary No. 9) which was originally tested on March 30-31, 1995. The original specimen failed in the first cycle of displacement to  $2\delta_y$  when the bottom beam flange-to-column flange weld fractured suddenly. On the left side of the beam web, the fracture propagated along the weld-column interface; on the right half of the beam web the fracture propagated into the column flange face in a crescent/divot shape. The shear tab also fractured from its bottom edge to the first bolt hole.

The repair schedule consisted of removing the beam material adjacent to the bottom weld access hole, repairing the large divot in the column flange by buttering it with weld material, removing the shear tab bolts, installing continuity plates for the top and bottom haunches, installing a beam web doubler plate on the side opposite to the existing shear tab and welding this to the column flange and beam web, groove welding the haunch flanges to the column flange and beam flanges, fillet welding the haunch webs to the beam flanges, and installing web vertical stiffeners at the end of the haunched region. The displacement loading history followed the standard SAC/ATC-24 protocol. The reference displacement ( $\delta_y$ ) we assumed to be 1.00 in. to provide consistency with the original test of this specimen.

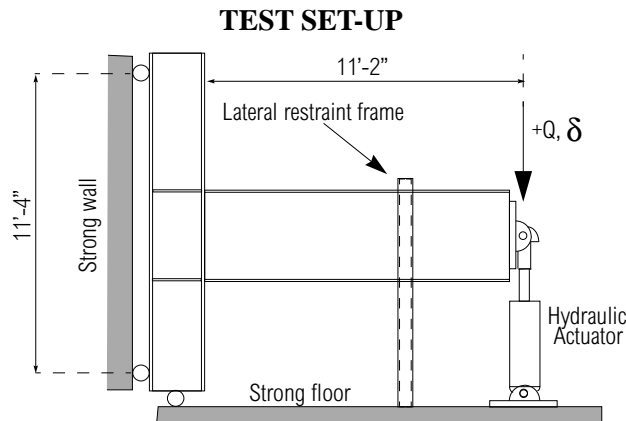
Applied Displacement History	Key Observations of the Test	
<p style="text-align: center;"><math>\delta_y = 1.0</math> in. (analytical, original specimen)</p>	Point	Description
	1	Yielding of beam top and bottom flanges outside the haunch
	2	Slight beam web yielding outside the haunch and some vertical stiffener yielding
	3	Buckling of beam flanges and web outside the haunch, slow reduction in load carrying capacity
	4	Severe beam flange and web buckling outside of haunch
	5	Test termination due to severe twisting of the specimen

Mode of failure: No material fracture or substantial degradation in strength observed; tests stopped after displacement cycles to  $4\delta_y$  due to severe twisting in the specimen.

Specimen UTA-3R exhibited yielding in the top and bottom flanges of the beam outside of the haunch region during the displacement cycles to  $0.75\delta_y$ . This yielding continued to spread during the displacement cycles to  $2\delta_y$  and  $3\delta_y$ . Slight yielding in the beam web outside of the haunch zone and in the web vertical stiffeners was also observed, and during the displacement cycles to  $3\delta_y$ , both the beam flanges and web started to buckle. The severity of buckling increased with each cycle, and the load maxima slowly reduced. At the completion of the  $3\delta_y$  cycles, the specimen was twisted substantially. During the first displacement cycle to  $4\delta_y$ , the beam experienced severe flange and web buckling, and the specimen was twisting severely at the face of the haunch. The test was stopped at this point to avoid damaging the loading apparatus. There was no sign of material fracture anywhere within the specimen. The maximum plastic rotation of the connection was approximately 2.3% radian (measured to the face of the column). Almost all of this rotation was associated with the beam.
