Specimen ID: UCB-RN1
 Keywords: Repaired, beam doubler plate, beam splice plate, column replacement piece, beam and column flange yielding, weld crack, medium rotation capacity
 Test Location: University of California, Berkeley
 Test Date: August 2, 1995
 Principal Investigator: Egor P. Popov; with Marcial Blondet, Lev Stepanov, and B. Stojadinovic
 Related Summaries: 10
 Reference: "Experimental Investigations of Beam-Column Subassemblages", *Report No. SAC 96-01*, March 1996.
 Funding Source: FEMA / SAC Joint Venture, Phase I

MATERIAL PROPERTIES AND SPECIMEN DETAILS

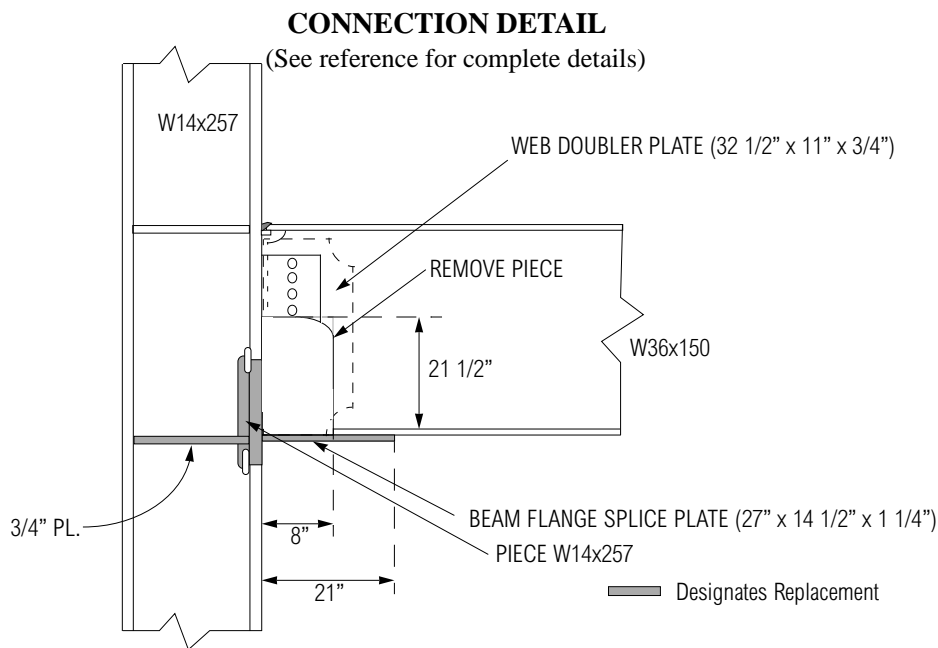
This was a test of repairs to specimen UCB-PN1 which was originally tested on February 9, 1995. The original specimen failed during the second positive excursion to $3\delta_y$. The failure mode was fracture of the column flange adjacent to the bottom beam flange. The failure initiated underneath the backing plate at the beam bottom flange weld. It extended diagonally across the flange and entered the corner of the panel zone. In the panel zone, the crack branched in two directions. Significant yielding in the column flanges and the lower part of the continuity plate was noted. Minor yielding in the panel zone and the beam flanges was observed. The reference loading displacement (δ_y) for the specimen was specified as 1.00 in.

The repair consisted of removing a section of the beam flange and web, removing the bottom continuity plate, removing a section of the column web and flange, replacing the removed column section with a new W14x257 Gr. 50 piece, welding the column flange and web, adding a beam splice plate to connect the beam bottom flange to the newly placed column piece, welding the existing shear tab to the beam web and removing the existing bolts, welding a new beam web doubler plate to the column flange and the beam web on the opposite side of the shear tab. The standard SAC/ATC-24 loading history was used in the testing, and the re-testing was performed quasi-statically.

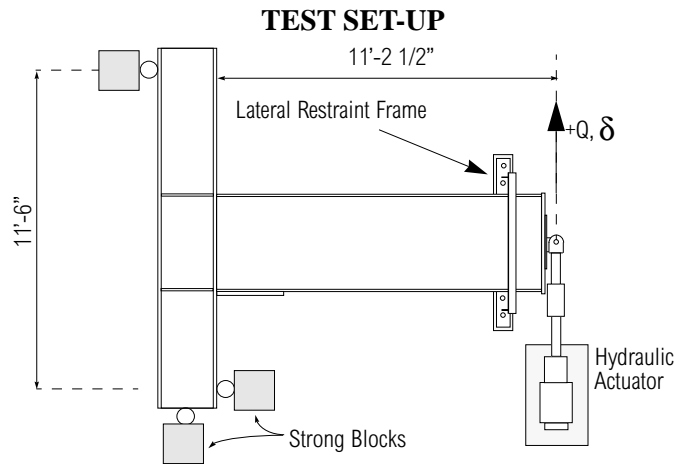
| Applied Displacement History | Key Observations of the Test | |
|--|---|--|
| | 1 | Yielding of the beam top flange, beam bottom splice plate, and back flange of the column at the bottom web stiffener |
| | 2 | Fracture of the beam top flange weld, initiating in the middle and propagating towards the edges. |

Mode of failure: Fracture of the beam top flange weld during the first negative $4\delta_y$ cycle.

Specimen UCB-RN1 behaved elastically up to and including the $1\delta_y$ cycles. The specimen sustained three displacement cycles at $2\delta_y$, and three displacement cycles at $3\delta_y$ with some yielding of the beam top flange, the beam bottom splice plate, and the back flange of the column at the lower continuity plate level. The measured beam flange strains significantly exceeded the yield value. Strain gages also indicated yielding in the panel zone. The specimen failed during the first negative excursion to $4\delta_y$. A fracture initiated at the middle of the beam top flange and propagated to the flange edges. Due to unloading, the crack stopped 1 in. short of the edges of the beam flange. The maximum plastic rotation of the connection was approximately 1.50% radian.
