Specimen ID: UCB-RN2
 Keywords: Repaired, doubler plate, beam flange plate, column replacement piece, haunch beam, panel zone, and column yielding, beam crack, medium rotation capacity
 Test Location: University of California, Berkeley
 Test Date: August 15, 1995
 Principal Investigator: Egor P. Popov; with Marcial Blondet, Lev Stepanov, and B. Stojadnovic
 Related Summaries: 11
 Reference: "Experimental Investigations of Beam-Column Subassemblages", Report No. SAC 96-01, March 1996.
 Funding Source: FEMA / SAC Joint Venture, Phase I

CONNECTION DETAIL

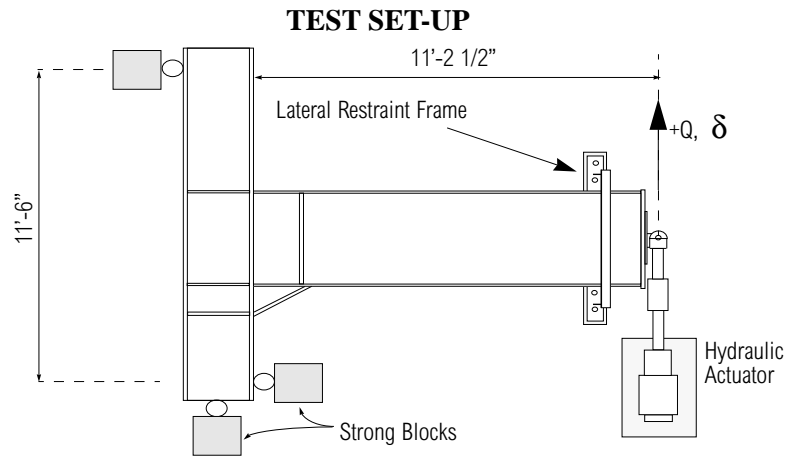
DISPLACEMENT HISTORY AND KEY EXPERIMENTAL OBSERVATIONS

Applied Displacement History	Key Observations of the Test	
<p style="text-align: center;">$\delta_y = 1.0$ in. (original specimen)</p>	Point	Description
	1	Yielding observed in the beam bottom flange near the haunch, the beam top flange, lower portion of the panel zone, and at the back of the column near the top continuity plate
	2	Fracture of the beam bottom flange at the connection between the haunch and the vertical web stiffener

Mode of failure: Fracture of the beam bottom flange at the connection between the haunch and the web stiffener during the first $5\delta_y$ cycle.

Specimen UCB-RN2 sustained all displacement cycles up to and including the $4\delta_y$ cycles with increasingly noticeable signs of yielding in the beam bottom flange near the haunch, in the beam top flange, in the lower panel zone, and on the back of the column flange opposite the top continuity plate. The specimen failed during the first $5\delta_y$ excursion, at a displacement of 4.02 in. A fracture initiated at the edge of the beam bottom flange at the intersection between the haunch and the vertical web stiffener, propagating along the haunch into the beam web. In the beam web, the crack branched in two with the first branch extending approximately 4 in. through the beam flange and 1 in. from the haunch edge, and the second branch stretching for approximately 1.5 in. diagonally through the beam web. The maximum plastic rotation of the connection was approximately 1.77% radian.
