Specimen ID: UCB-RN3
 Keywords: Repaired, new shear tab, beam yielding, top and bottom flange cracking, medium rotation capacity
 Test Location: University of California, Berkeley
 Test Date: July 20, 1995
 Principal Investigator: Egor P. Popov; with Marcial Blondet, Lev Stepanov, and B. Stojadinovic
 Related Summaries: 12
 Reference: "Experimental Investigations of Beam-Column Subassemblages", *Report No. SAC 96-01*, March 1996.
 Funding Source: FEMA / SAC Joint Venture, Phase I

BACKGROUND

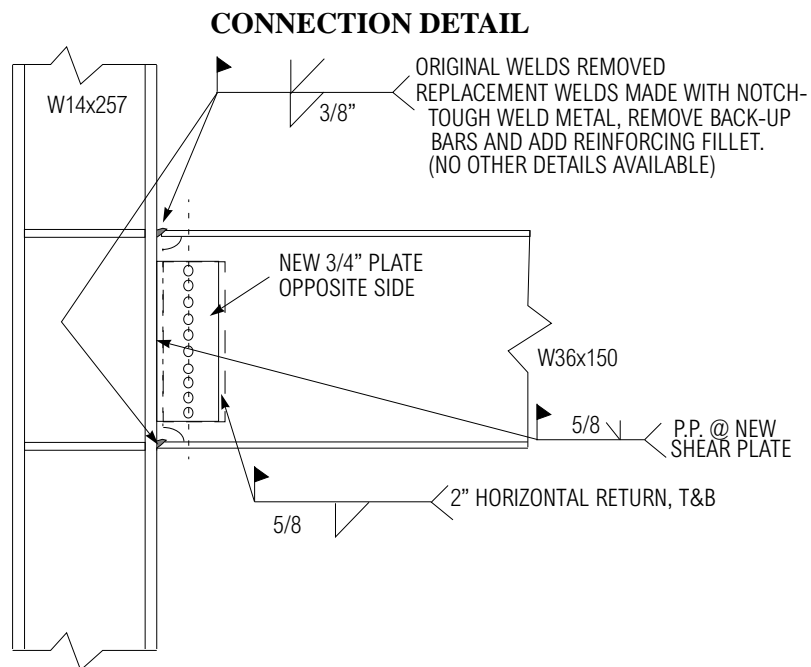
Member	Size	Grade	Yield Stress (ksi)		Ultimate Strength (ksi)	
			mill certs.	coupon tests *	mill certs.	coupon tests *
Beam	W36x150	A36	56.8	40.6 flange 49.6 web	68.7	57.4 flange 60.7 web
Column	W14x257	A572 Gr. 50	53.5	48.3 flange N.A. web	72.5	67.8 flange 76.1 web
Welding Procedure Specification	Original welds: WPS given in Test Summary No. 10. Repair welds: conforms with AWS D1.1-94 and be capable of delivering a minimum of 20 ft-lbs at 20 F as measured by a Charpy V-Notch impact test; no other details available					
Shear tab	New 3/4"x4"x30" plate on the opposite side of original, original bolts removed					
Panel zone	No doubler plates					
Continuity plates	1/2" plates with c.p. weld					
Boundary conditions	Single-sided test, no floor slab, axial load in bottom half of column equal to beam shear, specimen tested in flat position					
Other detailing	At bottom flange, remove B.U. bar, add 3/8" reinforcing fillet

The original specimen had fractured beam top and bottom flanges, and its repair procedure consisted of completely removing the entire fracture region and an extra 2 in. of sound metal in the top flange, completely removing the groove weld at the bottom flange, providing new complete penetration welds at the top and bottom flanges, removing the back-up bar and adding a 3/8 in. reinforcing fillet at the bottom flange, removing the remaining shear tab bolts and the shear tab plate, and welding a new shear tab on the opposite side of the beam web.

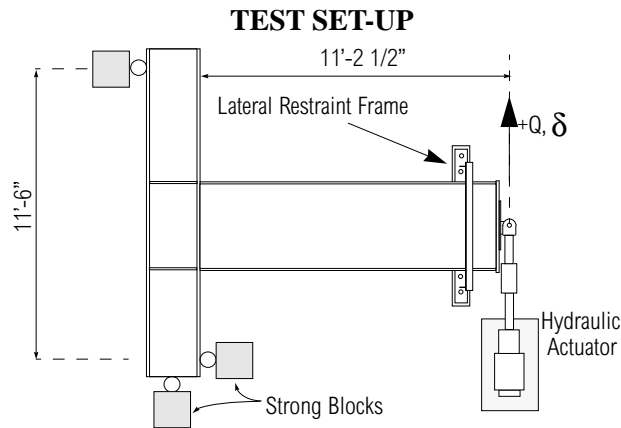
DISPLACEMENT HISTORY AND KEY EXPERIMENTAL OBSERVATIONS

Applied Displacement History	Key Observations of the Test	
	Point	Description
	1	Yielding in the beam web and the beam flanges
	2	Yielding observed in the panel zone
	3	Initiation of a fracture at the edge of the beam bottom flange, propagating through the flange, with a short branch near the flange axis
	4	Fracture of the top beam flange across its entire width

Mode of failure: Fracture of the beam bottom flange weld during the second positive displacement excursion to $4\delta_y$.

Specimen UCB-RN3 displayed visual indications of yielding during the first excursion to $2\delta_y$. The yielding occurred in the beam flanges and in the beam web near the weld access holes. After the completion of the first displacement excursion to $4\delta_y$, considerable nonlinearity in both beam flanges, in the beam web, and in the panel zone was noted. The specimen failed during the next displacement cycle to $4\delta_y$, at a displacement of 1.48 in. A fracture initiated at the edge of the beam bottom flange and propagated across the entire flange with a short branch near the flange axis. Loading was continued, and the positive and negative excursions were completed. During the first negative excursion to $5\delta_y$, the beam top flange fractured across its entire width. Prior to failure, the maximum plastic rotation of the connection was approximately 1.69% radian.
