Specimen ID: EERC-AN1
 Keywords: New connection, top and bottom cover plates, notch tough weld material, local buckling, fillet weld crack, net section fracture, medium rotation capacity
 Test Location: Earthquake Engineering Research Center, University of California at Berkeley
 Test Date: February 2, 1996
 Principal Investigator: Vitelmo V. Bertero; with Andrew S. Whittaker and Amir S. Gilani
 Related Summaries: none
 Reference: "Experimental Investigations of Beam-Column Subassemblages", *Report No. SAC 96-01*, March 1996.
 Funding Source: FEMA / SAC Joint Venture, Phase I

CONNECTION DETAIL

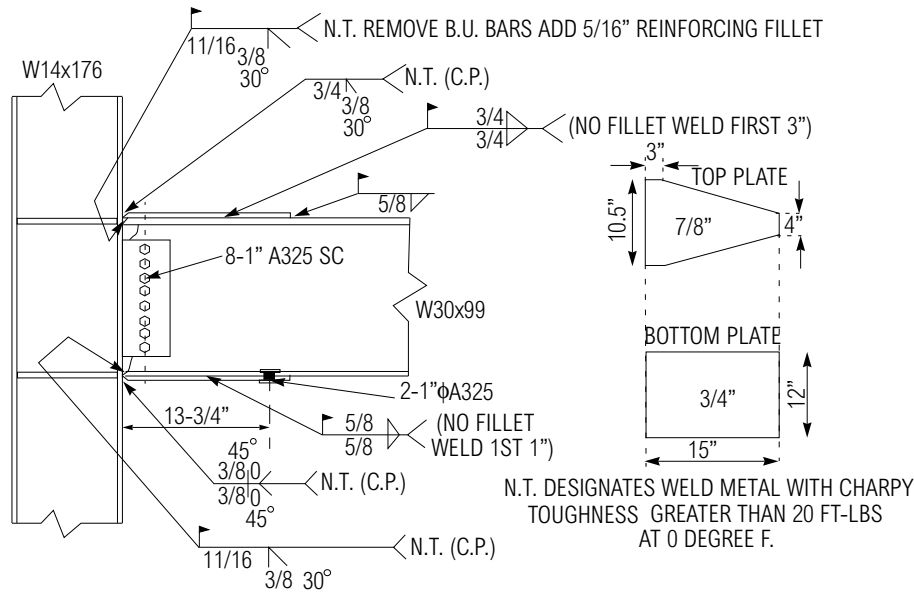
The beam was welded to the column using full-penetration groove welds with a notch-tough electrode (AWS E70TG-K2). The top cover plate was tapered to facilitate down-hand welding to the column and the beam top flange. The bottom cover plate was rectangular and wider than the beam flange to facilitate down-hand welding between the beam flange and the cover plate. The cover plates were groove welded to the column and fillet welded to the beam flanges. Two one-inch diameter A325 bolts were used to clamp the free end of the bottom cover plate to the beam bottom flange, thereby reducing the tendency for the end of the bottom cover plate to pry away from the beam flange. The standard SAC/ATC-24 loading history was used in the quasi-static testing of the specimen. The value of yield displacement (δ_y) was assumed to be 1.40 in. to provide consistency with the other specimens tested at EERC.
