Specimen ID: UCSD-6
 Keywords: New construction, straight haunch, vertical stiffeners, notch-tough electrode, haunch separation, local buckling, top flange fracture, medium rotation capacity
 Test Location: University of California, San Diego
 Test Date: September 19, 1995
 Principal Investigator: Chia-Ming Uang; with Duane Bondad
 Related Summaries: None
 Reference: "Experimental Investigations of Beam-Column Subassemblages", Report No. SAC 96-01, March 1996.
 Funding Source: FEMA / SAC Joint Venture, Phase I

MATERIAL PROPERTIES AND SPECIMEN DETAILS

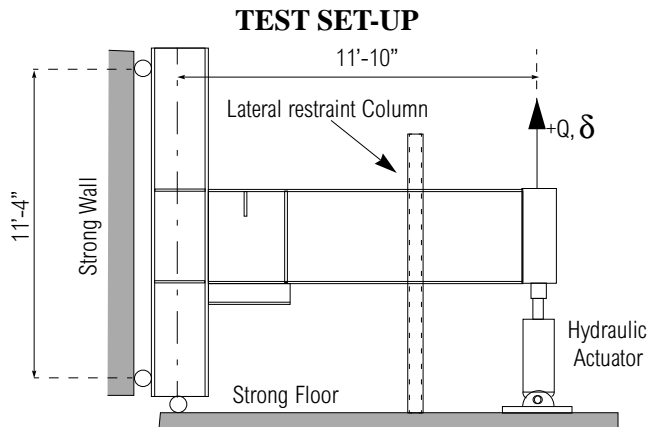
Applied Displacement History	Key Observations of the Test	
<p>$\delta_y = 1.4$ in. (analytical, original specimen)</p>	Point	Description
	1	Local yielding at the free end of the haunch
	2	Local yielding at the fixed end of the haunch
	3	Fracture of the fillet weld at the haunch end, haunch separation of 5.5 in.
	4	Local buckling of the beam top flange near column
	5	Complete separation of the haunch from beam; local buckling of beam bottom flange near column face
	6	Severe local buckling near the column of the beam top flange
7	Complete fracture of the beam top flange adjacent to the column

Mode of failure: Fracture of the beam top flange adjacent to the column during the first negative $4\delta_y$ cycle.

At the free end of the haunch, local yielding, due to stress concentration, was observed during the displacement cycles to $0.5\delta_y$. During the excursions to $0.75\delta_y$, local yielding at the fixed end of the haunch began to radiate from the top web access hole. This pattern continued during the excursions to $1\delta_y$. During the $2\delta_y$ cycles, yielding in the haunch web and upper panel zone continued to spread, and yielding in the lower panel zone was also observed. During the second positive excursion, the fillet weld at the end of the haunch fractured over a length of 5.5", due to the large stress concentration. During the first positive excursion of $3\delta_y$, local buckling of beam top flange next to the column was noted; the addition of the short stiffener did not prevent the local buckling from occurring near the column face. During the third positive excursion, the haunch completely separated from the bottom flange, leaving the specimen similar in geometry to a pre-Northridge specimen. Thus, the local buckling of the beam bottom flange radiated from outside the haunch to near the column face. The top flange experienced severe local buckling during the first positive excursion to $4\delta_y$, and the flange fractured during the following negative excursion. The maximum plastic rotation of the connection was approximately 3.5% radian. The repair scheme did not significantly improve the performance of the connection due to the detrimental effects of the stress concentration at the end of the haunch. To further improve the response of the connection, it is suggested either a sloped end to the haunch be provided, or vertical haunch stiffeners near the end of the haunch be provided on each side.
