Specimen ID: UTA-4
 Keywords: New connection, top and bottom cover plates, notch tough weld material, local buckling, fillet weld crack, specimen twisting, medium rotation capacity
 Test Location: University of Texas, Austin
 Test Date: January 11, 1996
 Principal Investigator: Michael D. Englehardt; with Bradley D. Shuey and Thomas A. Sabol
 Related Summaries: None
 Reference: "Experimental Investigations of Beam-Column Subassemblages", *Report No. SAC 96-01*, March 1996.
 Funding Source: FEMA / SAC Joint Venture, Phase I

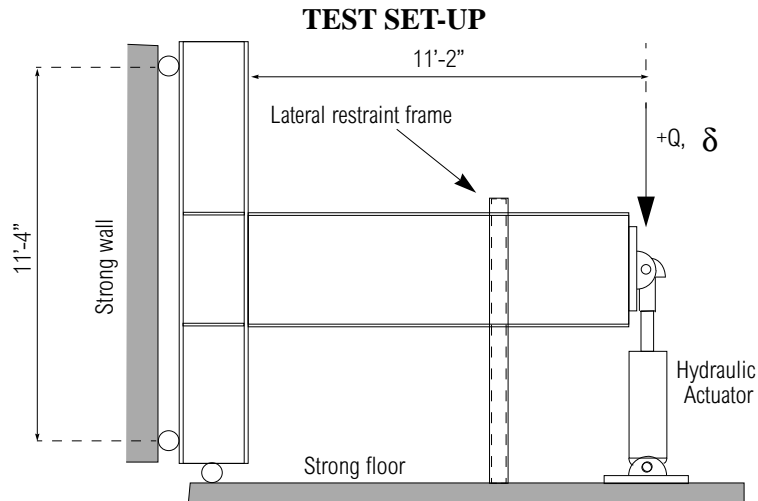
Applied Displacement History	Key Observations of the Test	
	Point	Description
	1	Yielding of the beam flanges at the tips of cover plates
	2	Panel zone yielding, progress of yielding into the cover plates, and visible column joint rotation
	3	Web yielding outside the cover plate region and increased flange yielding, small crack observed at the beam end of one of the cover plate to beam bottom flange fillet welds
	4	Beam flange and web buckling
	5	Growth of the fillet weld tear due to flange buckling
6	Test termination due to severe beam flange and web buckling and specimen twisting

Mode of failure: No material failure was observed in the specimen, and there was not a substantial loss of strength. The test was stopped after the $6\delta_y$ displacement cycle due to severe twisting of the specimen.

The test of specimen UTA-4 was terminated after the displacement cycles to $6\delta_y$ to avoid damaging to the loading ram and test apparatus. Severe beam flange and web buckling combined with twisting of the specimen was apparent. During the $1\delta_y$ cycles, the first significant yielding was noted at the beam flanges at the tips of the cover plates. The yielding increased and progressed into the cover plates during the later cycles. Panel zone yielding was observed during the first $2\delta_y$ cycle and was accompanied by slight bending in the column. This bending/panel zone action increased during the later cycles. After the completion of the $3\delta_y$ cycles, a small crack was discovered at the end of one of the fillet welds between the beam bottom flange and the cover plate. During the $4\delta_y$ cycles, flange and web buckling was visible and increased during the $5\delta_y$ and $6\delta_y$ cycles. The bottom flange fillet weld tear grew due to flange buckling during the later cycles. The weld tear had a final length of approximately 10 in. The specimen had substantial strength at the end of testing. The maximum plastic rotation of the connection was 3.7% radians. The contributions of the beam and the panel zone to this rotation were approximately 80% and 20%, respectively.
