Specimen ID: EERC-PN3  
 Keywords: Pre-Northridge, simulated field welding, panel zone yielding, weld fracture, small rotation capacity  
 Test Location: Earthquake Engineering Research Center, University of California at Berkeley  
 Test Date: March 29-30, 1995  
 Principal Investigator: Vitelmo V. Bertero; with Andrew S. Whittaker and Amir S. Gilani  
 Other Test Summaries: 15  
 Reference: "Experimental Investigations of Beam-Column Subassemblages," Report No. SAC 96-01, March 1996.  
 Funding Source: FEMA / SAC Joint Venture, Phase I

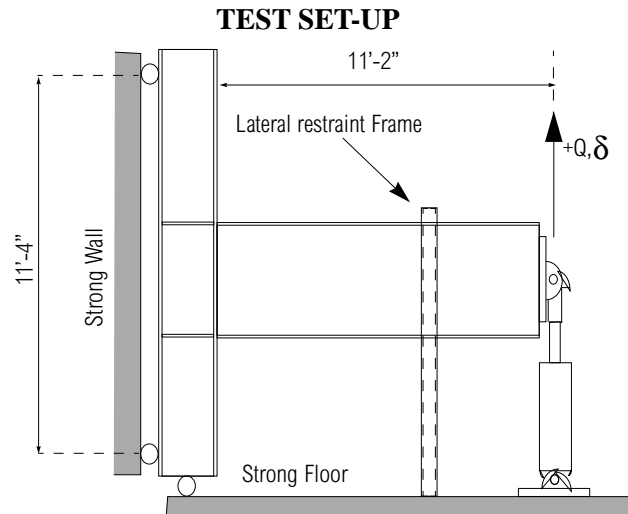
## DISPLACEMENT HISTORY AND KEY EXPERIMENTAL OBSERVATIONS

Applied Displacement History	Key Observations of the Test	
	Point	Description
	1	Shear yielding in the panel zone
	2	Local buckling of beam top flange; tensile yielding of beam bottom flange
	3	Local buckling of beam bottom flange
	4	Fracture of welded connection of beam top flange to column flange
5	Fracture of beam bottom flange groove weld

Mode of failure: Fracture of the welded beam top flange to column flange connection during the second negative  $3\delta_y$  cycle.

Specimen EERC-PN3 failed during the second negative displacement excursion to  $3\delta_y$ . The groove welded connection of the beam top flange to the column flange fractured at a beam tip displacement of approximately -3.3 in. during the excursion. After the failure, the test was continued and during the next positive cycle the beam bottom flange connection fractured. Failure of the specimen was preceded by shear yielding in the panel zone, observed starting in the first displacement cycle to  $0.75\delta_y$ . Local buckling of the top flange and tensile yielding of the bottom flange was noted during the third displacement cycle to  $2\delta_y$ . Pronounced buckling of both flanges was observed in the two  $3\delta_y$  cycles prior to the fracture. The maximum plastic rotation of the connection prior to failure was approximately 2.1% radian: 1.1% radian in the panel zone and 1.0% radian in the beam. The panel zone and the beam dissipated similar amounts of energy.
