Specimen ID: UCB-AN1
 Keywords: New construction, straight haunch, vertical stiffeners
 beam yielding, top flange fracture, access hole crack, medium rotation capacity
 Test Location: University of California, Berkeley
 Test Date: January 23, 1996
 Principal Investigator: Egor P. Popov; with Marcial Blondet, Lev Stepanov, and B. Stojadinovic
 Related Summaries: None
 Reference: "Experimental Investigations of Beam-Column Subassemblages", *Report No. SAC 96-01*, March 1996.
 Funding Source: FEMA / SAC Joint Venture, Phase I

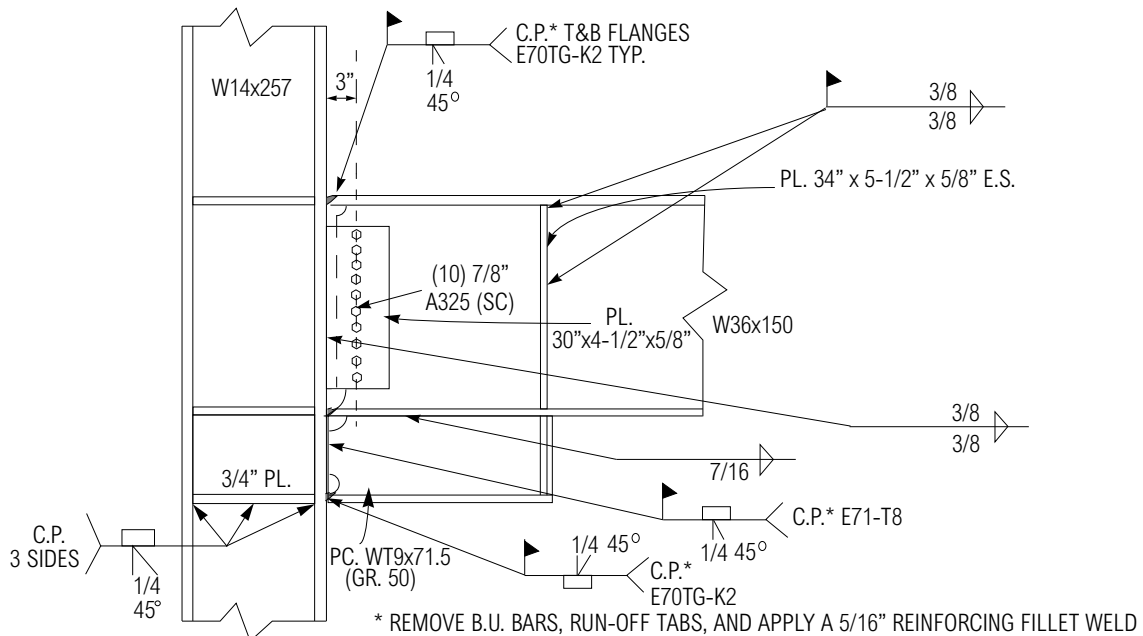
CONNECTION DETAIL

Material Properties	No mill certificates were supplied, and no coupon tests were performed
Welding Procedure Specification	Reference states only that "improved welding procedures" were used
Shear tab	5/8"x 5" plate with ten 7/8" A325 (SC) bolts
Panel zone	No doubler plates
Continuity plates	3/4" plates with c.p. weld, 3/4" plate at the haunch level with c.p. weld
Boundary conditions	Single-sided test, no floor slab, axial load in bottom half of column equal to beam shear, specimen tested in flat position
Other detailing	Add vertical stiffeners on each side, remove B.U. bars, add 5/16" reinforcing fillet weld

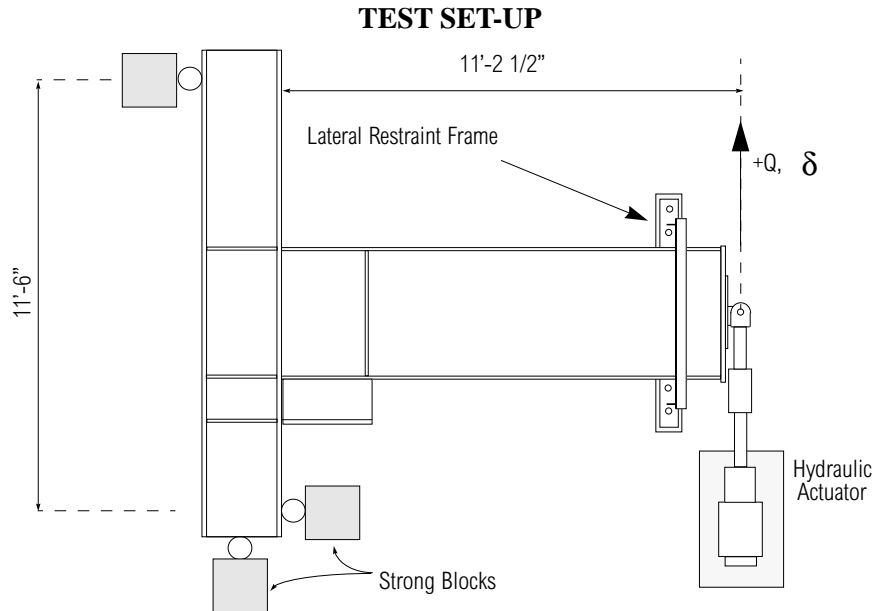
DISPLACEMENT HISTORY AND KEY EXPERIMENTAL OBSERVATIONS

Applied Displacement History	Key Observations of the Test	
	Point	Description
	1	Spalling of whitewash at beam top flange
	2	Spalling of whitewash in the panel zone
	3	Yielding of beam flanges, panel zone, beam web, back column flange opposite the top beam flange, and haunch web
	4	Slippage between the beam web and the shear tab
	5	Fracture of the beam top flange across the entire width
6	Shearing of the shear tab bolts, and cracking at the bottom access hole; widespread yielding throughout the specimen

Mode of failure: Fracture of the beam top flange across the entire width during the first negative $4\delta_y$ cycle.

Specimen UCB-RN1 sustained displacement cycles up to and including the initial positive excursion to $4\delta_y$. Yielding was first noted visually in the beam top flange above the vertical stiffener and near the column during the $0.5\delta_y$ cycles. After the excursions to $0.75\delta_y$, visual evidence of panel zone yielding was also noted. However, the overall response of the specimen up-to and including the $1\delta_y$ cycles could be defined as elastic. Starting with the $2\delta_y$ cycles, considerable yielding in the connection became evident. The nonlinearity was present in both beam flanges, in the panel zones, beam web, beam web stiffener, back column flange (opposite the beam top flange), and on the haunch web. During the last $3\delta_y$ cycle, slippage between the beam web and the shear tab, accompanied by loud bangs, was observed. The specimen failed suddenly during the first negative excursion to $4\delta_y$. The beam top flange fractured across the entire width near the flange weld. The crack started at the weld edge near the beam flange axis and then extended symmetrically to the flange edges. As the loading was continued, five shear tab bolts were sheared off and another fracture was initiated at the bottom access hole. The maximum plastic rotation of the connection was approximately 1.53% radian.
