Specimen ID: UCSD-1
 Keywords: Pre-Northridge, simulated field welding, beam bottom flange fracture, shear tab fracture, small rotation capacity
 Test Location: University of California, San Diego
 Test Date: February 16, 1995
 Principal Investigator: Chia-Ming Uang; with Duane Bondad
 Related Summaries: 17
 Reference: "Experimental Investigations of Beam-Column Subassemblages", Report No. SAC 96-01, March 1996.
 Funding Source: FEMA / SAC Joint Venture, Phase 1

CONNECTION DETAIL

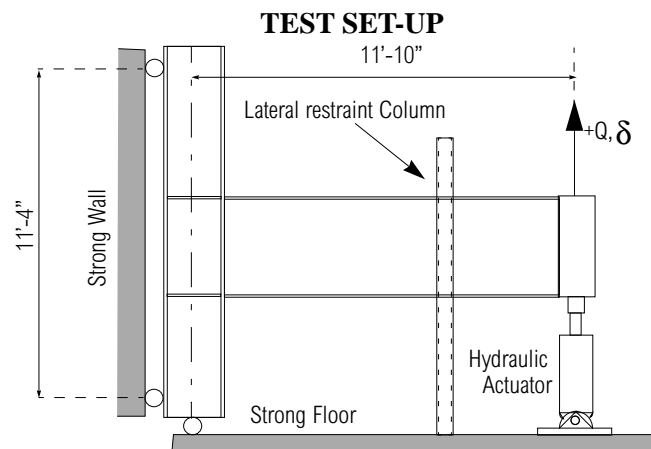
DISPLACEMENT HISTORY AND KEY EXPERIMENTAL OBSERVATIONS

Applied Displacement History	Key Observations of the Test	
	Point	Description
	1	Shear yielding in the panel zone
	2	Complete fracture of beam bottom flange in the fusion zone between the column flange and beam bottom flange groove weld
3	Fracture of supplemental weld on the bottom of the shear tab

Mode of failure: Fracture of the welded beam bottom flange to column flange connection during the first half-cycle to $2\delta_y$ cycle.

Specimen UCSD-1 failed during the first half-cycle displacement excursion to $2\delta_y$. The specimen behaved elastically during the first six cycles of the test. The specimen yielded in the next three cycles of $1\delta_y$ displacement amplitude. The stable hysteretic behavior during these cycles was primarily a result of shear yielding in the panel zone. The specimen failed suddenly in the first excursion to $2\delta_y$. At 2.4 in., a complete fracture developed across the beam bottom flange width in the heat affected zone between the column flange and groove weld. As a result, the neighboring supplemental web weld also fractured. Data from the strain gages on the bottom flange of the beam indicated axial strains due to flexure exceeding 17,000 micro-strain. However, little sign of beam yielding was observed after the test. Flaking of the whitewash clearly indicated that yielding occurred in the panel zone. In the post-elastic range, the measured shear strain in the center of the panel zone was approximately 50% higher than the average shear strain. The maximum plastic rotation of the joint prior to failure was approximately 0.79% radian, consisting of 0.60% radian from the panel zone, and 0.39% radian from the beam (note that these values are not directly additive due to the way the individual quantities are defined). Examination of plots of beam plastic rotation and panel zone plastic rotation versus moment at the face of column indicated that the panel zone dissipated substantially more energy than the beam.
