Specimen ID: UCSD-3
 Keywords: Pre-Northridge, simulated field welding, shear tab fracture, backup bar yielding, fracture of top beam flange groove weld
 Test Location: University of California, San Diego
 Test Date: March 2, 1995
 Principal Investigator: Chia-Ming Uang; with Duane Bondad
 Related Summaries: 19
 Reference: "Experimental Investigations of Beam-Column Subassemblages", Report No. SAC 96-01, March 1996.
 Funding Source: FEMA / SAC Joint Venture, Phase 1

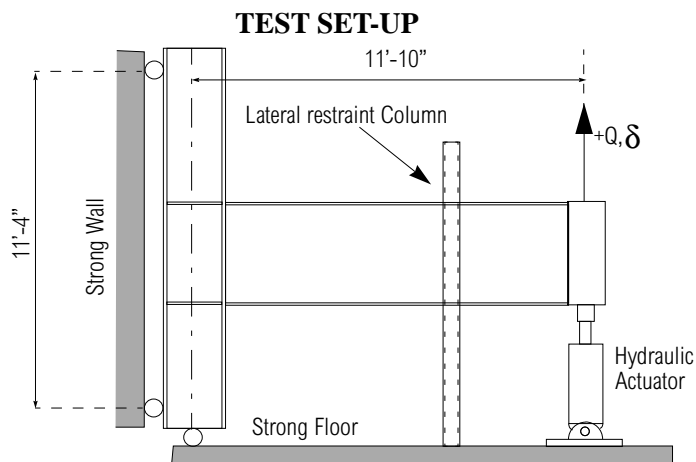
DISPLACEMENT HISTORY AND KEY EXPERIMENTAL OBSERVATIONS

Applied Displacement History	Key Observations of the Test	
	Point	Description
	1	Minor shear yielding in the panel zone
	2	Fracture of the toe of the lower beam web access hole
	3	Vertical fracture of top end of shear tab, hairline crack in the middle of top flange near weld
	4	Fracture of bottom end of shear tab
	5	Fracture of upper beam web access hole
	6	2 in. fracture of beam bottom flange near weld, minor local buckling of top flange, yielding of backup bar
	7	Complete fracture of top flange across the groove weld

Mode of failure: Fracture of the beam top flange groove weld during the first negative $3\delta_y$ cycle.
