Specimen ID: UTA-2  
 Keywords: Pre-Northridge, simulated field welding, column flange fracture, shear tab bolt failure, small rotation capacity  
 Test Location: University of Texas, Austin  
 Test Date: March 24, 1995  
 Principal Investigator: Michael D. Englehardt; with Bradley D. Shuey and Thomas A. Sabol  
 Related Summaries: 22  
 Reference: "Experimental Investigations of Beam-Column Subassemblages", Report No. SAC 96-01, March 1996.  
 Funding Source: FEMA / SAC Joint Venture, Phase 1

### CONNECTION DETAIL

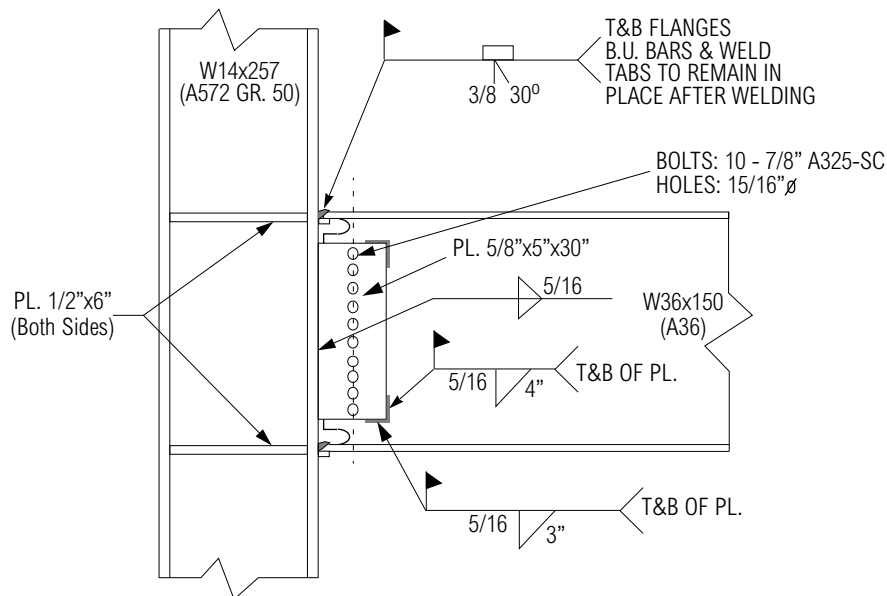
Member	Size	Grade	Yield Stress (ksi)		Ultimate Strength (ksi)	
			mill certs.	coupon tests *	mill certs.	coupon tests *
Beam	W36x150	A36	58.5	42.3 flange 47.7 web	67.5	61.1 flange 63.4 web
Column	W14x257	A572 Gr. 50	53.5	48.7 flange	72.5	69.0 flange
Welding Procedure Specification	Fillet Weld: FCAW-SS; 0.072" diameter AWS E71T-8 electrode; conforms with AWS 5.20 specification and Section 4.2 of AWS D1.1-94 CJP groove weld: FCAW-SS; 0.120" diameter AWS E70T-4 electrode; conforms with AWS 5.20 specification and Section 4.2 of AWS D1.1-94					
Shear tab	5/8"x30"x5" plate with ten 7/8" A325 bolts					
Panel zone	No doubler plates					
Continuity plates	1/2" plates with c.p. weld					
Boundary conditions	Single-sided test, no floor slab, axial force in lower half of column equal to beam shear force, specimen tested in upright position					
Other detailing	Leave backup bars and weld tabs in place, root defects determined from UT inspection left in place

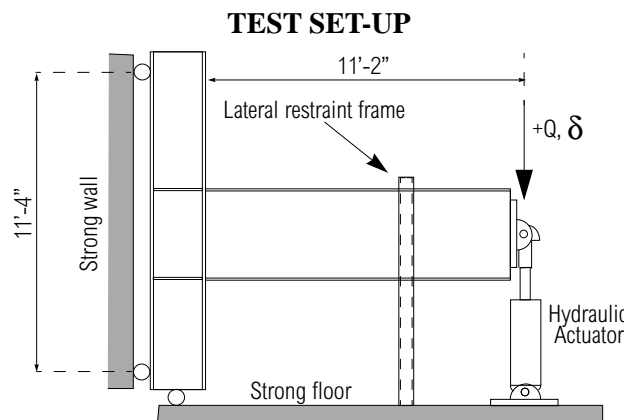
## DISPLACEMENT HISTORY AND KEY EXPERIMENTAL OBSERVATIONS

Applied Displacement History	Key Observations of the Test	
	Point	Description
	1	Yielding of beam flanges
	2	Beam flange yielding is more pronounced; gap appeared between bottom flange backing bar and column flange
	3	Panel zone yielding, presence of a small (0.5 in.) crack at the lower supplementary web weld
	4	Small cracking of upper supplementary web weld, bolt slip and yielding in shear tab, cracking of top flange groove weld above the web
	5	Fracture of beam bottom flange connection in the form of divot fractures on both sides of the web
6	Failure of three shear tab bolts

Mode of failure: "Divot" fracture of column flange adjacent to the beam bottom flange connection during the second positive displacement excursion to  $2\delta_y$ .

Specimen UTA-2 failed in the first half of the second displacement cycle to  $2\delta_y$ . Prior to failure, the beam flanges yielded in the  $0.75\delta_y$  and  $1.0\delta_y$  cycles. During the  $\delta_y$  cycles, the panel zone also yielded, and a small gap appeared between the beam bottom flange backing bar and the column flange. During the first cycle to  $2\delta_y$ , small cracks were discovered at the upper and lower supplementary vertical web welds, and some bolt slip in the shear tab was noted. In addition, a crack was noted directly over the beam web in the beam top flange groove weld. A sudden fracture occurred at the beam bottom flange connection during the next cycle. Through-thickness delaminations (or “divot” fractures) appeared in the column flange on both sides of the beam web. The fracture extended from the weld root into the column flange and resurfaced on the column flange face approximately 0.5 in. above the beam bottom flange. The fracture to the right of the web formed a crescent shape that extended from the weld root and terminated inside of the column flange. After this failure was observed, the specimen was loaded to a displacement of 2.75 in. During this extended cycle three of the shear tab bolts failed. The specimen experienced plastic deformations and rotations. The maximum plastic rotation of the connection was approximately 0.6% radian. The beam contribution was approximately 2/3 of this value.
