Specimen ID: UTA-3
 Keywords: Pre-Northridge, simulated field welding, weld fracture, column flange fracture, shear tab fracture, small rotation capacity
 Test Location: University of Texas, Austin
 Test Date: March 16, 1995
 Principal Investigator: Michael D. Englehardt; with Bradley D. Shuey and Thomas A. Sabol
 Related Summaries: 23
 Reference: "Experimental Investigations of Beam-Column Subassemblages", *Report No. SAC 96-01*, March 1996.
 Funding Source: FEMA / SAC Joint Venture, Phase 1

CONNECTION DETAIL

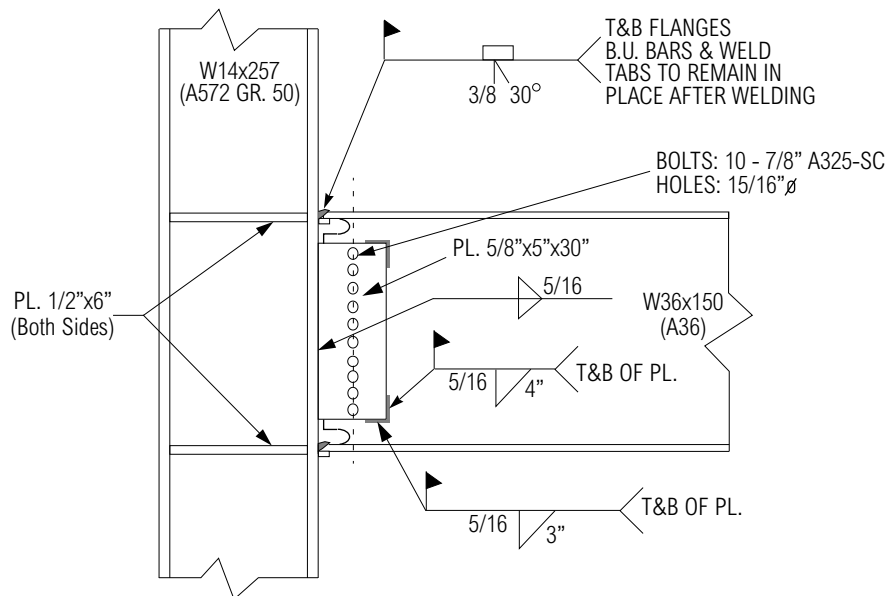
Mode of failure: Fracture of the beam bottom flange connection during the first positive displacement excursion to $2\delta_y$.

Specimen UTA-3 failed in the first half of the first cycle to $2\delta_y$ at a beam tip displacement of 1.81 in. Prior to failure, yielding of the beam flanges was noted during the displacement excursions to $0.75\delta_y$ and $1\delta_y$. Failure occurred when a fracture developed in the welded connection between the beam bottom flange and the column flange at a displacement of 1.81 in. On the left half of the beam bottom flange, the fracture propagated along the weld-column interface; on the right half of the beam flange, the fracture propagated into the column flange face in a crescent/divot shape. The divot fracture extended from the weld root and terminated inside the column flange. The fracture appeared to reach a depth of 1 in. in the column flange. The shear tab also fractured from the bottom edge to the first bolt hole. The specimen experienced negligible yielding, and the maximum plastic rotation of joint was approximately 0.3% radian.
