Specimen ID: UCSD-6
 Keywords: New construction, straight haunch, vertical stiffeners, notch-tough electrode, haunch separation, local buckling, top flange fracture, medium rotation capacity
 Test Location: University of California, San Diego
 Test Date: September 19, 1995
 Principal Investigator: Chia-Ming Uang; with Duane Bondad
 Related Summaries: None
 Reference: "Experimental Investigations of Beam-Column Subassemblages", Report No. SAC 96-01, March 1996.
 Funding Source: FEMA / SAC Joint Venture, Phase I

MATERIAL PROPERTIES AND SPECIMEN DETAILS

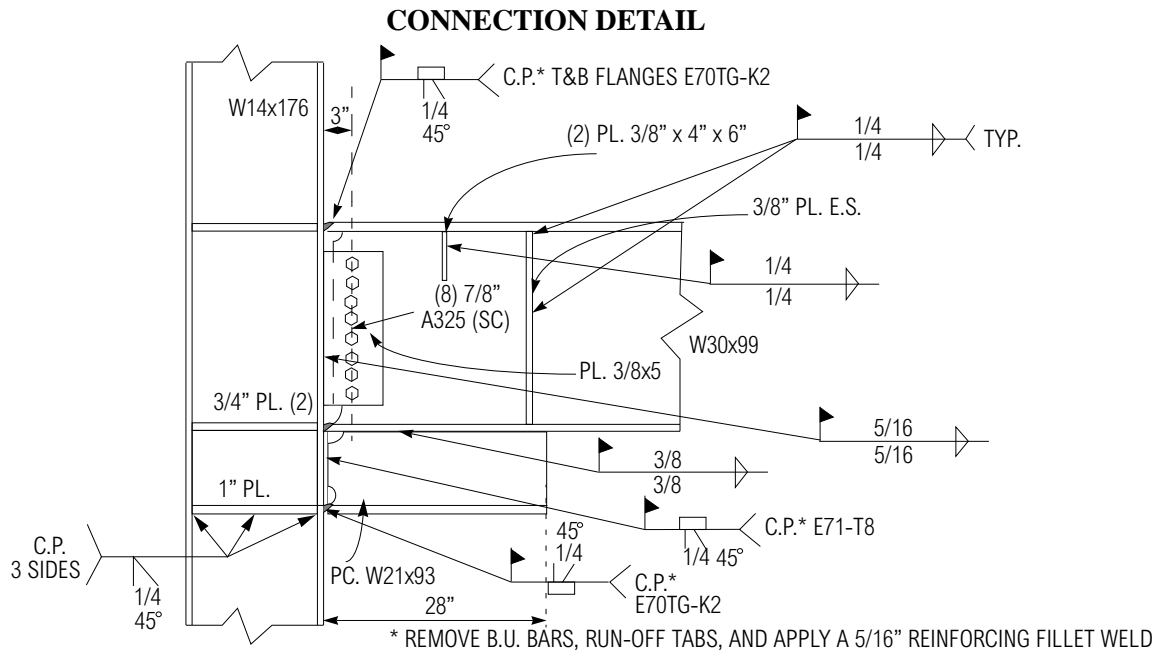
Mode of failure: Fracture of the beam top flange adjacent to the column during the first negative $4\delta_y$ cycle.

At the free end of the haunch, local yielding, due to stress concentration, was observed during the displacement cycles to $0.5\delta_y$. During the excursions to $0.75\delta_y$, local yielding at the fixed end of the haunch began to radiate from the top web access hole. This pattern continued during the excursions to $1\delta_y$. During the $2\delta_y$ cycles, yielding in the haunch web and upper panel zone continued to spread, and yielding in the lower panel zone was also observed. During the second positive excursion, the fillet weld at the end of the haunch fractured over a length of 5.5", due to the large stress concentration. During the first positive excursion of $3\delta_y$, local buckling of beam top flange next to the column was noted; the addition of the short stiffener did not prevent the local buckling from occurring near the column face. During the third positive excursion, the haunch completely separated from the bottom flange, leaving the specimen similar in geometry to a pre-Northridge specimen. Thus, the local buckling of the beam bottom flange radiated from outside the haunch to near the column face. The top flange experienced severe local buckling during the first positive excursion to $4\delta_y$, and the flange fractured during the following negative excursion. The maximum plastic rotation of the connection was approximately 3.5% radian. The repair scheme did not significantly improve the performance of the connection due to the detrimental effects of the stress concentration at the end of the haunch. To further improve the response of the connection, it is suggested either a sloped end to the haunch be provided, or vertical haunch stiffeners near the end of the haunch be provided on each side.
