Specimen ID: UTA-4
 Keywords: New connection, top and bottom cover plates, notch tough weld material, local buckling, fillet weld crack, specimen twisting, medium rotation capacity
 Test Location: University of Texas, Austin
 Test Date: January 11, 1996
 Principal Investigator: Michael D. Englehardt; with Bradley D. Shuey and Thomas A. Sabol
 Related Summaries: None
 Reference: "Experimental Investigations of Beam-Column Subassemblages", *Report No. SAC 96-01*, March 1996.
 Funding Source: FEMA / SAC Joint Venture, Phase I

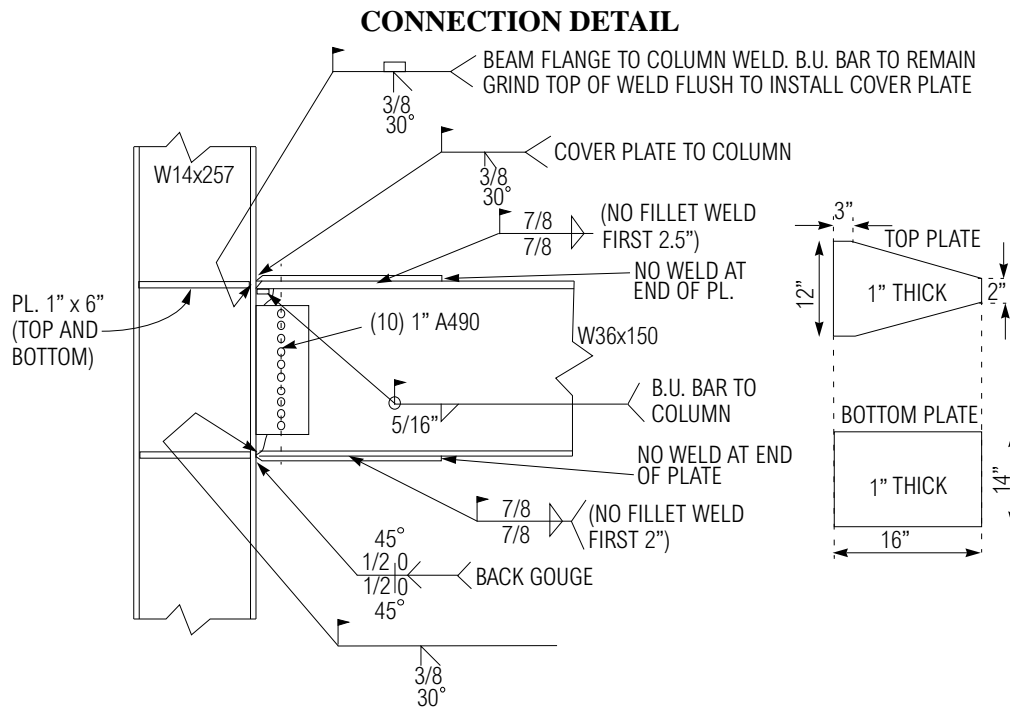
Mode of failure: No material failure was observed in the specimen, and there was not a substantial loss of strength. The test was stopped after the $6\delta_y$ displacement cycle due to severe twisting of the specimen.

The test of specimen UTA-4 was terminated after the displacement cycles to $6\delta_y$ to avoid damaging to the loading ram and test apparatus. Severe beam flange and web buckling combined with twisting of the specimen was apparent. During the $1\delta_y$ cycles, the first significant yielding was noted at the beam flanges at the tips of the cover plates. The yielding increased and progressed into the cover plates during the later cycles. Panel zone yielding was observed during the first $2\delta_y$ cycle and was accompanied by slight bending in the column. This bending/panel zone action increased during the later cycles. After the completion of the $3\delta_y$ cycles, a small crack was discovered at the end of one of the fillet welds between the beam bottom flange and the cover plate. During the $4\delta_y$ cycles, flange and web buckling was visible and increased during the $5\delta_y$ and $6\delta_y$ cycles. The bottom flange fillet weld tear grew due to flange buckling during the later cycles. The weld tear had a final length of approximately 10 in. The specimen had substantial strength at the end of testing. The maximum plastic rotation of the connection was 3.7% radians. The contributions of the beam and the panel zone to this rotation were approximately 80% and 20%, respectively.
