Specimen ID: UCSD-3
 Keywords: Pre-Northridge, simulated field welding, shear tab fracture, backup bar yielding, fracture of top beam flange groove weld
 Test Location: University of California, San Diego
 Test Date: March 2, 1995
 Principal Investigator: Chia-Ming Uang; with Duane Bondad
 Related Summaries: 19
 Reference: "Experimental Investigations of Beam-Column Subassemblages", Report No. SAC 96-01, March 1996.
 Funding Source: FEMA / SAC Joint Venture, Phase 1

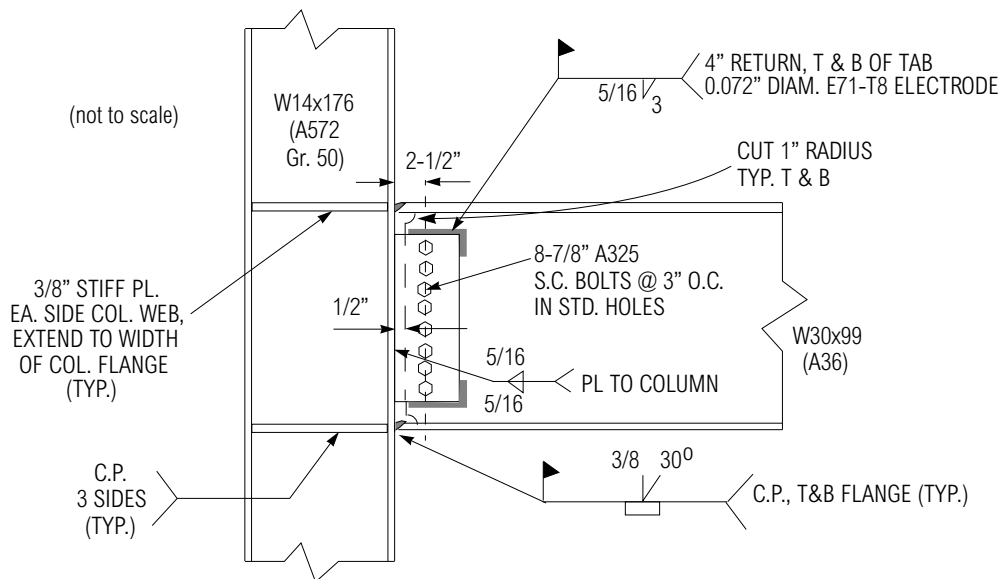
CONNECTION DETAIL

Member	Size	Grade	Yield Stress (ksi)		Ultimate Strength (ksi)	
			mill certs.	coupon tests *	mill certs.	coupon tests *
Beam	W30X99	A36	54.1	46.5 flange 57.1 web	73.4	67.7 flange 72.5 web
Column	W14X176	A572 Gr. 50	56.0	52.5 flange 51.2 web	75.0	68.2 flange 67.2 web
Welding Procedure Specification	All welds FCAW-SS in conformance with AWS D1.1-94, performed with 0.120" diameter AWS E70T-4 electrodes. Preheat and interpass temperature per Table 4.3. Fillet weld of shear tab to beam web performed with 0.072" diameter AWS E71T-8 electrode.					
Shear tab	3/8 x 5" plate with eight 7/8" A325 SC bolts					
Panel zone	No doubler plates					
Continuity plates	3/8" plates with C.P. weld					
Boundary conditions	Single-sided test, no floor slab, axial force in bottom of column equal to beam shear force, specimen tested in upright position					
Other detailing	Connection between column and beam welded in the upright position; backup bars left in place

Mode of failure: Fracture of the beam top flange groove weld during the first negative $3\delta_y$ cycle.
