Specimen ID: UCSD-2
 Keywords: Pre-Northridge, repair defective beam bottom flange groove weld, beam top flange and shear tab fracture, local buckling, small rotation capacity
 Test Location: University of California, San Diego
 Test Date: February 23, 1995
 Principal Investigator: Chia-Ming Uang; with Duane Bondad
 Related Summaries: 18
 Reference: "Experimental Investigations of Beam-Column Subassemblages", Report No. SAC 96-01, March 1996.
 Funding Source: FEMA / SAC Joint Venture, Phase 1

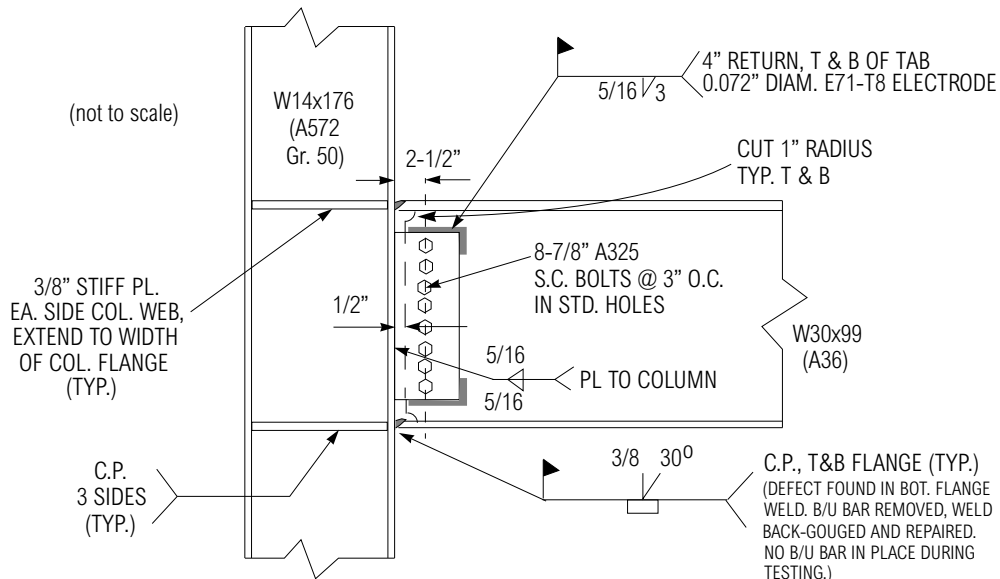
CONNECTION DETAIL

Member	Size	Grade	Yield Stress (ksi)		Ultimate Strength (ksi)	
			mill certs.	coupon tests *	mill certs.	coupon tests *
Beam	W30X99	A36	54.1	46.5 flange 57.1 web	73.4	67.7 flange 72.5 web
Column	W14X176	A572 Gr. 50	56.0	52.5 flange 51.2 web	75.0	68.2 flange 67.2 web
Welding Procedure Specification	All welds FCAW-SS in conformance with AWS D1.1-94, performed with 0.120" diameter AWS E70T-4 electrodes. Preheat and interpass temperature per Table 4.3. Fillet weld of shear tab to beam web performed with 0.072" diameter AWS E71T-8 electrode.					
Shear tab	3/8 x 5" plate with eight 7/8" A325 SC bolts					
Panel zone	No doubler plates					
Continuity plates	3/8" plates with C.P. weld					
Boundary conditions	Single-sided test, no floor slab, axial force in bottom of column equal to beam shear force, specimen tested in upright position					
Other detailing	Repair defective bottom flange groove weld, remove backup bar at the beam bottom flange

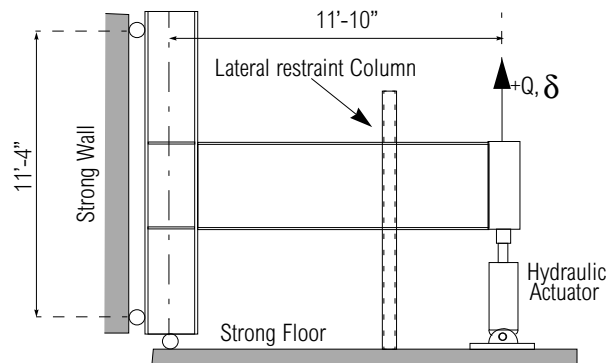
TEST SET-UP

The standard SAC/ATC-24 loading history was used in the quasi-static testing of the specimen. The yield displacement (δ_y) of the specimen was determined to be 1.40 in., utilizing nonlinear analysis.
